Conservation Guideline

The site of the project (the “Site”) is located at 15A Tai Hang Road, Wan Chai, Hong Kong. The Location Plan is shown at **Appendix II**.

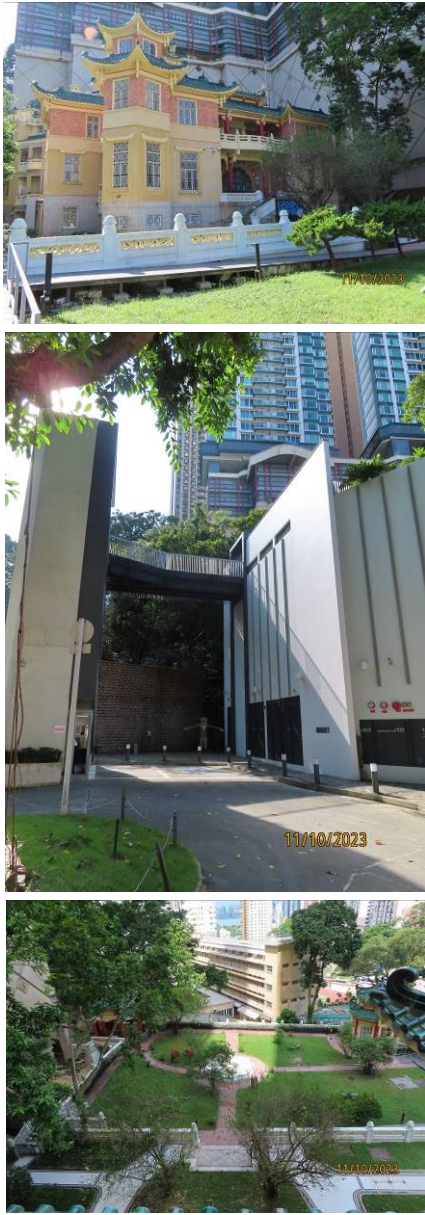
Item No.	Architectural Features to be Preserved and Conservation Guidelines	Photo
A.1	<p><u>Setting and context</u></p> <p>Integrity of the Main Site and its spatial arrangements within the Main Site and with the Ancillary Site.</p> <p>Required Treatment:</p> <ul style="list-style-type: none"> ● The original spatial arrangements of the Haw Par Mansion (thereafter the Mansion) and the Garden should be preserved. ● Any proposed new addition should be built with a compatible design that induce minimum visual impact on the heritage site. ● All heights of the proposed new addition should be kept equal to or below the level of the Mansion to minimize the adverse visual impact on the perception of the integrity of the Mansion. ● If addition or alteration work is necessary with justifications, the disturbance to the historic fabric of the building and Garden should be kept to a minimum. ● Treatment to setting and layout of the Garden treatment (Refer to Item No. D.1). ● Any proposed works within the Main Site and the Ancillary Site including but not limited to demolition, additions and alteration of the ancillary buildings should be submitted to AMO for comment and approval before implementation. <p>Recommended Treatments:</p> <ul style="list-style-type: none"> ● Service block, lift and staircase block housing portable and flushing tank and pump room, FS and sprinkler tank and pump room, switch room, accessible lift and staircase, and additional landscape deck to serve the Main Site with connecting footbridges had been constructed at the Ancillary Site to meet the modern-day requirements. Reuse these later-added facilities as far as possible.

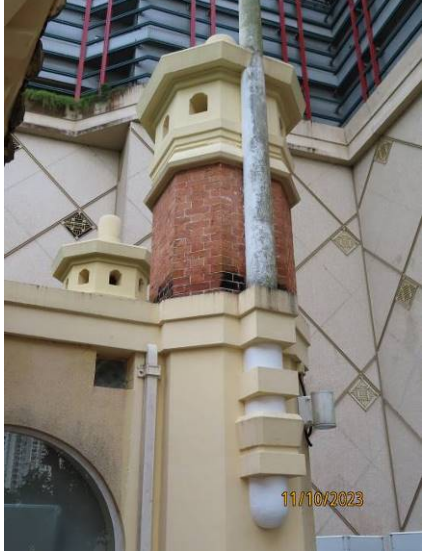
Item No.	Architectural Features to be Preserved and Conservation Guidelines	Photo
B.3	<p><u>Brickwork chimney stacks</u> at the upper roof.</p> <p>Required Treatments:</p> <ul style="list-style-type: none">● Brickwork chimney stacks should be preserved in-situ.● Repair, re-plaster, and repaint the chimney stacks to match with existing materials, profile and colour as necessary. No painting to the fair-face brickworks is allowed. Proper cleaning of bricks with appropriate methods.

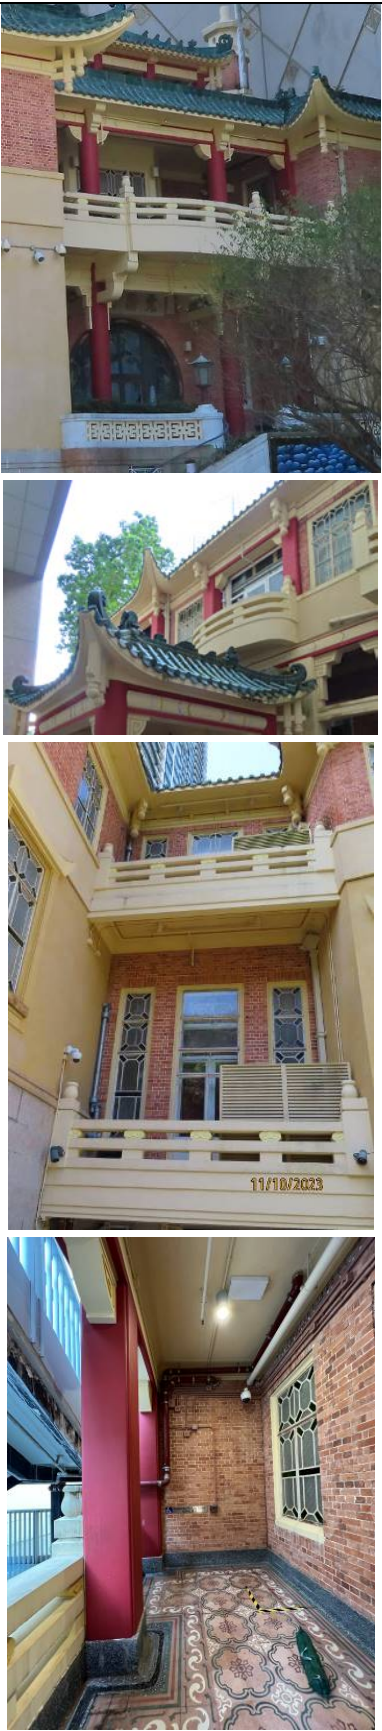
Item No.	Architectural Features to be Preserved and Conservation Guidelines	Photo
B.4	<p><u>Balconies and verandahs at main block and corridors at servants' quarters</u> with parapet walls of decorative grille design in painted Shanghai plaster finish or parapet walls with horizontal bands design in paint finish. Architectural features also including the columns, beams and brackets with geometric patterns, crown moulded ceilings, parapet walls, balustrades, patterned mosaic floor tiles, patterned ceramic tile flooring, terrazzo skirting and surface channels, historic light fittings and the like etc.</p> <p>Required Treatments:</p> <ul style="list-style-type: none"> ● The balconies and verandahs with the mentioned architectural features should be preserved in-situ. The open ambience and natural ventilation of balconies, verandahs and corridors should be kept intact. No further enclosure of balconies, verandahs and corridor, wholly or partially is permitted. ● Entire balconies, verandahs and columns including all architectural features should be preserved in-situ. ● Any upgrading works of parapet and balustrades or works to remedy level difference to meet the statutory requirements should be avoided as far as practicable to minimize further disturbance to existing balconies, verandahs, and corridors, subject to the approval of Buildings Authority. In case upgrading works are necessary with justifications, they should be carried out in a reversible manner. The design should be distinguishable from and compatible with historic fabric and subject to AMO's approval. ● No alteration to openings, formation of new openings, installation of suspended ceiling system or other permanent features in the balconies, verandahs and terraces are permitted. ● Repair, re-plaster, and repaint the painted areas to match with existing materials, profile and colour as necessary.

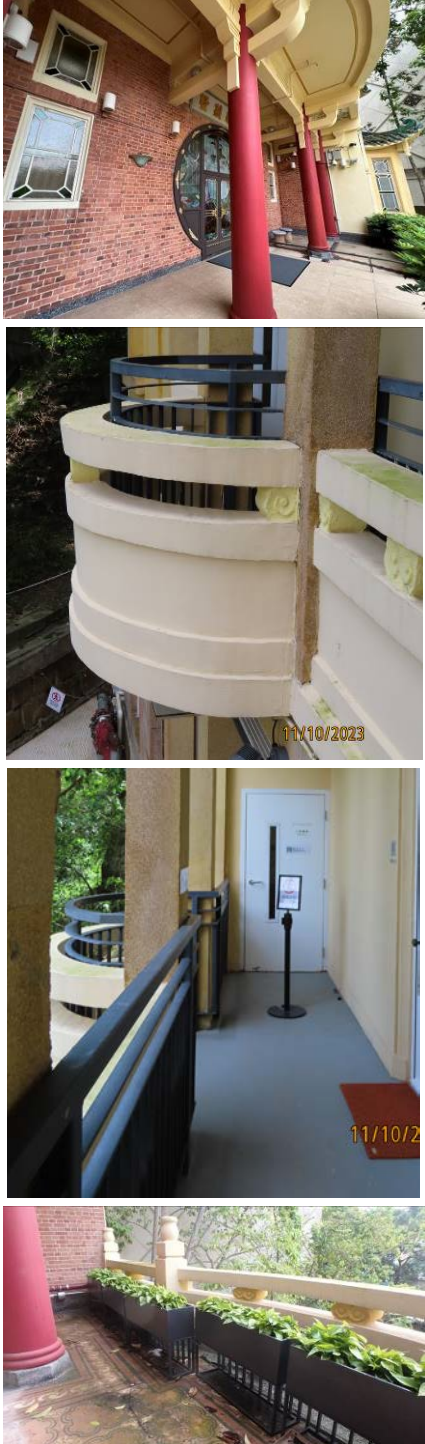
Item No.	Architectural Features to be Preserved and Conservation Guidelines	Photo
B.4	<p><i>(cont'd)</i></p> <p>Recommended Treatments:</p> <ul style="list-style-type: none"> ● Alteration and addition works had been carried out previously to meet the modern-day requirements. Reuse the later-added facilities as far as possible. ● Check for proper operation and repair as necessary: <ul style="list-style-type: none"> – Additional balustrades were installed in front of balustrades along the corridor of servants' quarters on roof to meet protective barrier requirements. – Raised deck was partially installed at the verandah on G/F facing the Garden to provide barrier free access from the main hall to the verandah on G/F. ● Management approaches, including placing pot planters along the existing parapets of the balconies and verandahs to prevent people from approaching the balustrade that is lower than 1.1m high, using movable ramp at door openings to the balconies where allow accessibility, and restricted access to some balconies for maintenance only etc. were adopted to strike a balance between maintaining the architectural authenticity and complying with the statutory requirements in the previous statutory submissions. The plants selected should be safety to visitors. ● Adoption of a similar management approaches as far as possible to preserve the existing parapets and floor finishes of the balconies and verandahs is recommended. ● Treatment to later-added partitions erected at G/F southeast terrace and 1/F southwest balcony. (Refer to Item No. B.1)

<p>The photo column contains four images: 1) A red cylindrical pillar supporting a yellow ceiling on a brick verandah. 2) A close-up of a white, curved balcony balustrade with a dark metal handrail. 3) An interior hallway with a white door and a blue carpet. 4) A balcony with a white balustrade and a long black planter box containing green plants.</p>

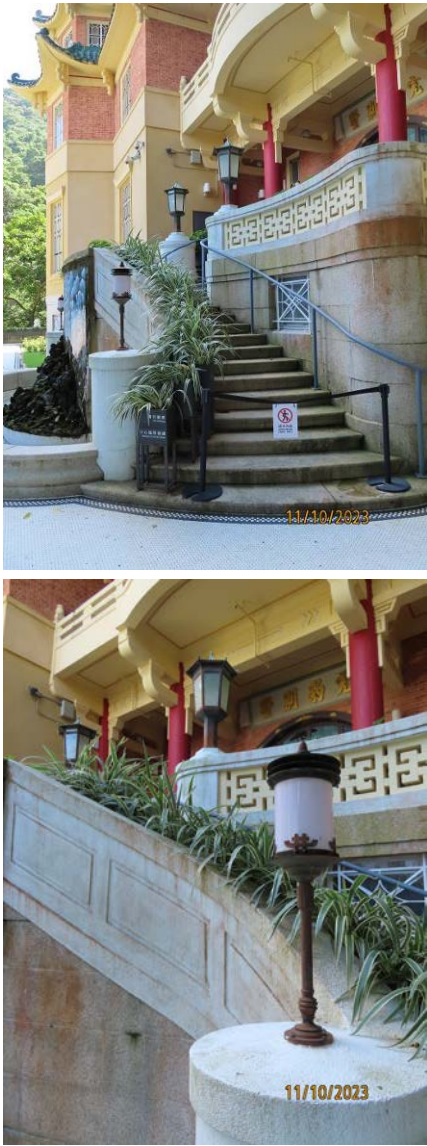
Item No.	Architectural Features to be Preserved and Conservation Guidelines	Photo
B.5	<p><u>The Palladian staircase</u> is supported by fair-face granite blocks and completed with a granite retaining wall and decorative balustrades in painted Shanghai plaster finish.</p> <p>Required Treatments:</p> <ul style="list-style-type: none"> ● The Palladian staircase including the mentioned architectural features should be preserved in-situ. ● Repair and clean the granite blocks and painted Shanghai plaster balustrades to match with existing as necessary. The granite blocks should be kept fair-faced. The methodology for cleaning granite blocks should be heritage friendly. ● Further upgrading works of the balustrades to meet the statutory requirements should be avoided as far as practicable so as to minimize further disturbance to the Palladian staircase, subject to the approval of Buildings Authority. In case upgrading works are required, works should be designed in a heritage friendly way and carried out in a reversible manner. The design should be distinguishable from and compatible with historic fabric and subject to AMO’s approval. <p>Recommended Treatments:</p> <ul style="list-style-type: none"> ● New metal handrail had been added previously to the side of granite blocks. Reuse the handrails as far as possible to avoid further disturbance to the Palladian staircase. ● Management approach, including placing pot planters along the existing balustrades prevent people from approaching the balustrade that is lower than 1.1m high, was adopted to strike a balance between maintaining the architectural authenticity and complying with the statutory requirements in the previous statutory submission. The plants to be used should be safety to visitors. ● Adoption of a similar management approach as far as possible to preserve the Palladian staircase is recommended.

<p>The top photograph shows a wide view of the Palladian staircase, featuring a decorative balustrade with a metal handrail on the right side. The staircase is supported by granite blocks. The bottom photograph is a close-up of the balustrade, showing a decorative lamp post and a pot planter with green plants. Both photos have a date stamp of 11/10/2023.</p>

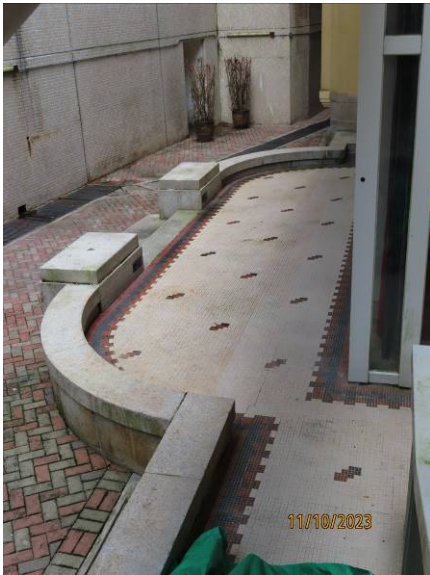
Item No.	Architectural Features to be Preserved and Conservation Guidelines	Photo
B.7	<p><u>Southeast terrace of the Mansion</u> including granite steps, low granite fence wall, and patterned mosaic tiled flooring etc.</p> <p>Required Treatments:</p> <ul style="list-style-type: none"> ● The Southeast terrace including the mentioned architectural features should be preserved in-situ. ● All stonework and mosaic tiles should be cleaned with bristle or nylon brushes and clean water; corrosive cleaning chemicals should not be used. Stonework and mosaic tiles should not be painted. ● Repair any missing or damaged mosaic tiles to match with existing materials, size, pattern and colour as necessary. ● During the last revitalisation works, part of the patterned mosaic tiled flooring was reinstated with similar mosaic tiles matching with the historic mosaic tiles after the excavation works for the construction of new open staircase, glass enclosure and provision of service trench. Any further excavation work for services routing should not damage the historic patterned mosaic tiled floor. <p>Recommended Treatments:</p> <ul style="list-style-type: none"> ● Reuse the underground services trench for piping and ducting which constructed in the last revitalisation works to avoid further disturbance to the Southeast terrace. ● Treatments to later-added open staircase and glass enclosure (refer to Item No. B.1).

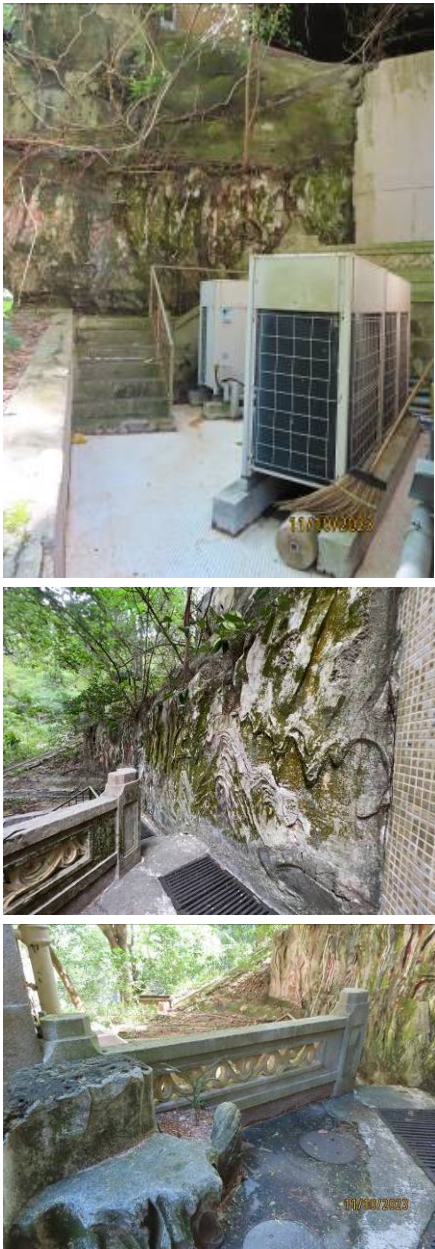
Item No.	Architectural Features to be Preserved and Conservation Guidelines	Photo
B.8	<p><u>Steps, landing, fence wall and retaining wall at the east corner of the Mansion</u> including the low boundary fence walls with decorative balustrades and posts in shanghai plaster finishes and the historic plaster work of Tiger Balm Garden remains at retaining wall.</p> <p>Required Treatments:</p> <ul style="list-style-type: none"> ● The steps, landing, fence wall and retaining wall including the mentioned architectural features should be preserved in-situ. ● Alteration to the low boundary fence walls is not allowed unless with strong justification and subject to AMO’s approval. ● Repair and clean the concrete steps and landing, low boundary fence and the retaining wall with water to match with existing as necessary. ● The historic plaster work remains on retaining walls and adjacent to low boundary fence walls are the evidence of Tiger Balm Garden, should be preserved in-situ and up-kept using the traditional methods.

<p>The photo column contains three images. The top image shows a concrete landing with a large air conditioning unit and a broom. The middle image shows a retaining wall with textured, historic plaster. The bottom image shows a decorative balustrade on a stone landing.</p>

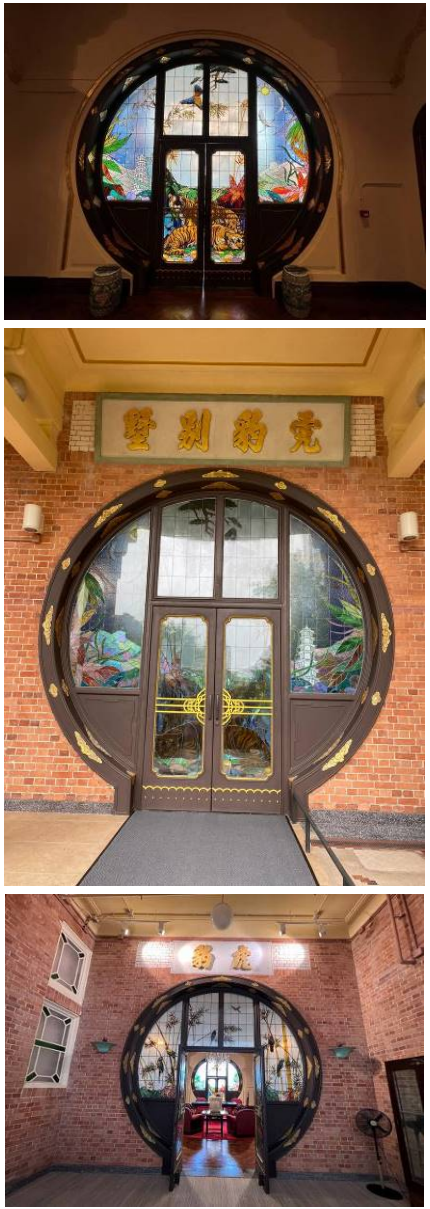
Item No.	Architectural Features to be Preserved and Conservation Guidelines	Photo
B.9	<p><u>Stained glass moon gates</u> on ground floor facing the Northwest (Garden) and Southeast (the Legend) sides with timber frame which is painted with decorative pattern and gilded with gold, and complete with side screens and fanlights and terrazzo door thresholds; and the <u>building signage</u> above inscribed with wordings “虎豹別墅” & “虎豹”.</p> <p>Required Treatments:</p> <ul style="list-style-type: none"> ● Preserve in-situ the stained glass moon gates including all historic stained glass and the timber frames, the door thresholds and the lintel above the entrance engraved with the building name. ● Do not change the design, configurations and colour. ● Repair, repaint and re-gilding the defective areas to match with existing design and materials as necessary. ● Clean the stained glass with a suitable mild solvent as necessary (as recommended by a specialist). <p>Recommended Treatments:</p> <ul style="list-style-type: none"> ● The original stained glasses on the side screens of the moon gate facing the Garden had been broken and replaced with clear glass many years ago before the site handed over to the Government. These two pieces of glass panes were then newly replaced with present-day design using original fixing method during the last revitalisation works. Reuse and keep these later-added glass panes in-situ, unless historic reference of the original appearance is available and restoration work to the original appearance could be considered. ● Informative plaque should be placed next to the moon gate to allow accurate interpretation of these two pieces of the new stained glass panes.

<p>The 'Photo' column contains three images of the stained glass moon gate. The top image is an interior view looking through the circular gate. The middle image is an exterior view of the gate set in a brick wall, with a sign above it that reads '虎豹別墅' (Tiger Leopard Villa) in gold characters. The bottom image is an interior view from a different angle, showing the gate and the brick wall.</p>

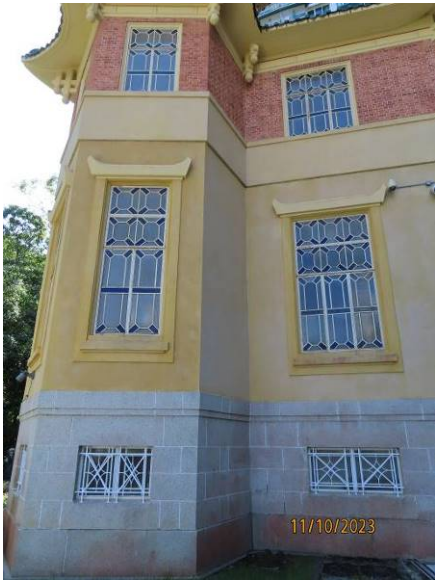
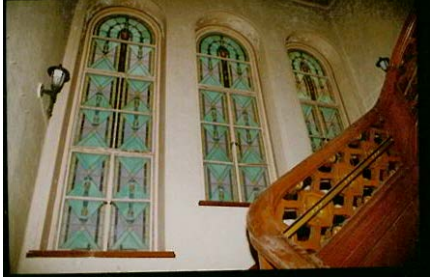
Item No.	Architectural Features to be Preserved and Conservation Guidelines	Photo
B.10	<p><u>Stained glass or patterned and obscured/ colour glass panes or clear glass windows and doors</u>³ with fanlights, painted metal frames, period-style ironmongeries, metal grilles and moulded window and door surrounds. Some of the windows and doors are decorated with hand-painted drawings.</p> <p>Required Treatments:</p> <ul style="list-style-type: none"> ● The existing windows and doors including the glass panes, metal frames and the surrounds and the hand-painted drawings on doors and windows should be preserved in-situ. No window or door opening is to be enlarged or modified unless with sound justification and subject to AMO’s approval. ● Conservation of hand-painted drawings on metal doors and windows could only be carried out by specialist with relevant experience as necessary. Any repainting/ consolidation methods should be submitted to AMO for approval. ● Many of the original stained glass panes have been removed and kept properly for protection, and temporarily replaced by plain glass panes. The original stained glass panes which are now stored in crates should be properly kept on-site. ● Repaint the metal window frames, metal grilles, repair the ironmongeries and replace the defective plain and obscured/colour glass panes to match with the existing materials, design configuration, and texture as necessary. <p>Recommended Treatments:</p> <ul style="list-style-type: none"> ● The original stained glass panes now stored on-site should be repaired and restored in their original locations by a historic glazing specialist as far as practicable. All repair and reinstatement methods should be submitted to AMO for approval

<p>Stained glasses before removal for protection</p>

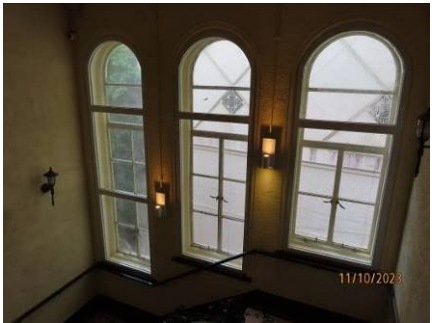
<p>Stained glass replaced by plain glasses</p>

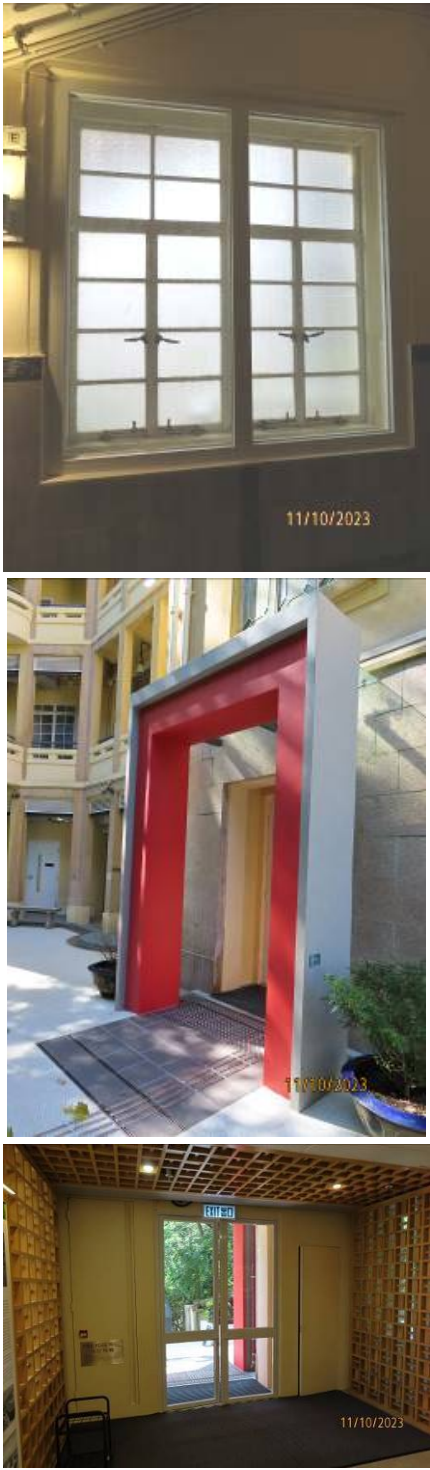
Item No.	Architectural Features to be Preserved and Conservation Guidelines	Photo
B.10	<p><i>(cont'd)</i></p> <ul style="list-style-type: none"> ● Modification works had been carried out to the existing window and door openings previously to meet the modern-day requirements. Reuse the later-additions as necessary or consider restoration of windows or doors to the original in case of change of design in future. ● Check for proper operation and repair as necessary: <ul style="list-style-type: none"> – Later-added fire rated glazing were installed at the internal side of windows and doors adjacent to the open staircase, at the stairwell of the internal staircase and along corridor at servants' quarters to meet fire safety requirements. – A window opening on G/F was enlarged to form entrance door to meet barrier free requirement on LG/F. – Original metal framed door of 1/F lobby (original verandah) connecting to the open staircase was modified and replaced with new metal glazed door to meet barrier free and fire safety requirements. – Some of the metal framed windows at the servants' quarters on LG/F had been blocked to meet fire safety requirement. – Some of the G/F windows was modified with louvre or installed with exhaust fan at the internal side for mechanical ventilation purpose. – Secondary metal framed window or door were installed at the internal side of some of the original metal framed windows and doors for acoustic purpose. ● Wall mounted timber cabinets or furniture were placed in front of the windows at the internal side to provide additional barrier to openable window with bottom height less than 1.1m. Adoption of a similar approach to meet protective barrier requirement as far as possible to avoid modification of original windows. ● Management approach, including restricted access to master bathroom for guided tour and maintenance only and placing tensile barriers in front of windows and

<p>The 'Photo' column contains three images. The top image shows a window with multiple panes and a dark frame, with a date stamp '11/10/2023' in the bottom right. The middle image shows a bright red-framed entrance door set within a grey wall, with a date stamp '11/10/2023' in the bottom right. The bottom image shows an interior lobby with wall-mounted timber cabinets on both sides and a glass door leading outside, with a date stamp '11/10/2023' in the bottom right.</p>

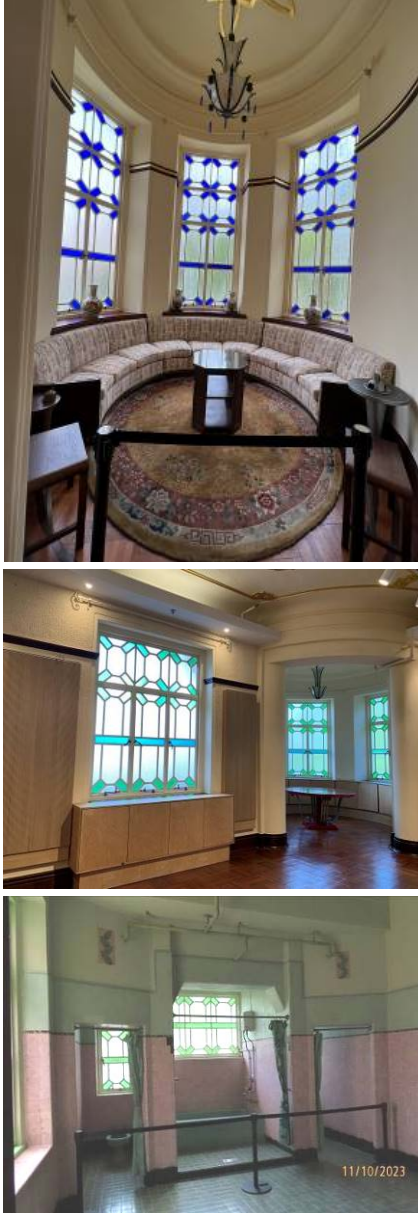
Item No.	Architectural Features to be Preserved and Conservation Guidelines	Photo
B.10	<p><i>(cont'd)</i></p> <p>sanitary wares etc. was adopted to avoid addition of protective barrier to some of the metal framed windows in the previous statutory submission</p> <ul style="list-style-type: none"> ● Adoption of a similar management approach as far as possible to minimize the disturbance to the metal framed windows is recommended.

<p>The 'Photo' column contains three images. The top image shows a circular room with a curved sofa, a central table, and a chandelier, with three large windows featuring blue and white stained glass. The middle image shows a hallway with a large window with green and white stained glass. The bottom image shows a room with a window and a metal railing, with a date stamp '11/10/2023' in the bottom right corner.</p>

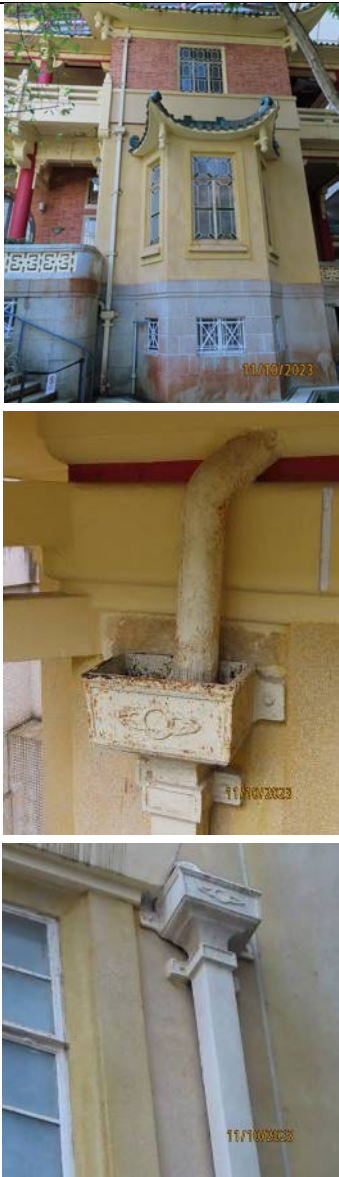
Item No.	Architectural Features to be Preserved and Conservation Guidelines	Photo
B.11	<p><u>Historic cast iron drain pipe and fittings</u> including cast iron rainwater downpipes and hopper heads.</p> <p>Required Treatments:</p> <ul style="list-style-type: none"> ● All historical cast iron drainage pipes including the hopper heads and their associated parts, should be preserved in-situ as far as practicable. ● Reuse the existing drainage system including the historic drainage pipes as far as practicable. ● Repair by de-rusting and repainting, or replace by replica if beyond repair.

<p>The photo column for item B.11 contains three vertically stacked photographs. The top photo shows a yellow building facade with a decorative cast iron drain pipe and hopper head. The middle photo is a close-up of a similar cast iron hopper head mounted on a wall. The bottom photo shows a white-painted cast iron drain pipe with a decorative hopper head. Each photo has a small orange timestamp '11/10/2023' in the bottom right corner.</p>

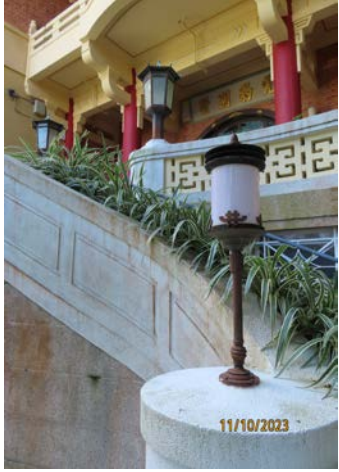
B.12	<p><u>Antique lanterns</u> with ironwork and opaque glass panes at the G/F verandah and Palladian Staircase facing the Garden.</p> <p>Required Treatments:</p> <ul style="list-style-type: none"> ● The iron lanterns should be preserved in-situ <p>Recommended Treatments:</p> <ul style="list-style-type: none"> ● Restore its function if it is technically feasible.

<p>The photo column for item B.12 contains one photograph showing an antique lantern with a white glass pane and ornate ironwork, mounted on a stone pedestal on a verandah. The background shows a building with a staircase and a decorative railing. A small orange timestamp '11/10/2023' is visible in the bottom right corner of the photo.</p>

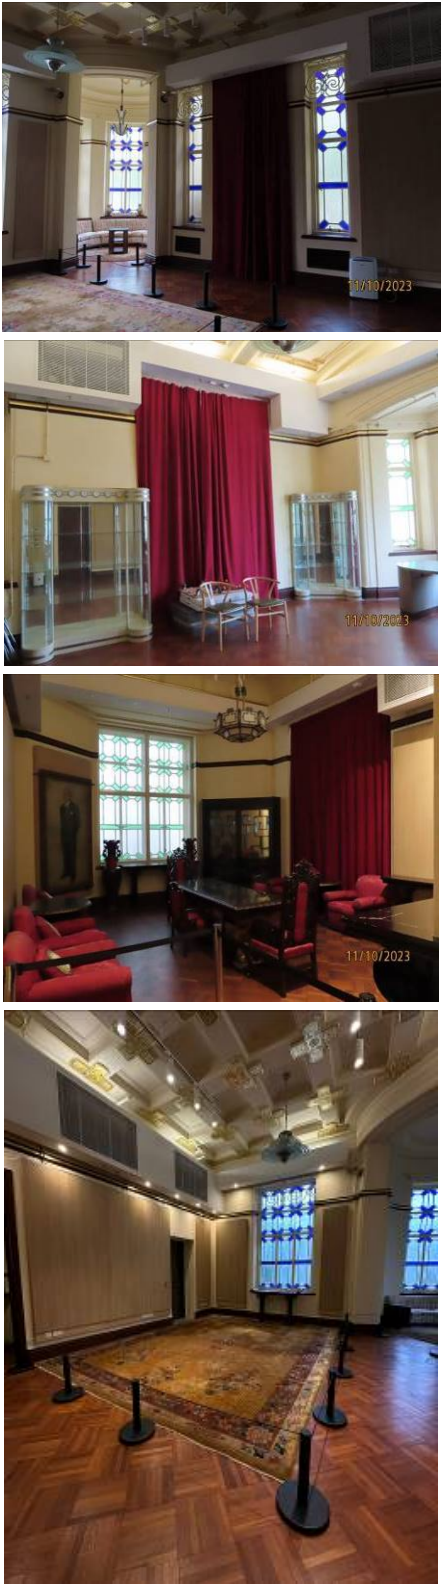
Item No.	Architectural Features to be Preserved and Conservation Guidelines	Photo
C.1	<p><u>Original building layout</u>, in particular the partitioning on G/F to R/F at the main block area which are authentic, including the configuration of Main Hall (original sitting room) and the classrooms (originally rooms for entertainment, dining and study) on G/F and Hallways, and 4 classrooms (original en-suite bedrooms) on 1/F.</p> <p>Required Treatments:</p> <ul style="list-style-type: none"> ● The original building layout should be preserved in-situ. For the main block area of the Mansion, no removal of internal walls or new openings made to all partitions is allowed unless with sound justification and subject to AMO’s approval, in order to keep the structure and the original room layout intact. ● Provide proper interpretation areas for interpretation on the cultural significance of the Site and the demolished Tiger Balm Garden, including allocating spaces for display of old items and furniture related to the Site and the demolished Tiger Balm Garden. <p>Recommended Treatments:</p> <ul style="list-style-type: none"> ● Alteration and addition works had been carried out previously to meet the modern-day and users’ requirements. Reuse the existing layout, spatial configuration and later-added facilities as far as possible. ● Check for proper operation and repair as necessary: <ul style="list-style-type: none"> – Addition of lift and conversion of the east end of the main block area connecting the servants’ quarters into lift lobbies to provide barrier free access from LG/F to R/F of the Mansion. – Reconstruction of staircase at servants’ quarters from G/F to R/F with associated structural strengthening works to meet MOE requirements. – Repartitioning of the servants’ quarters layout to

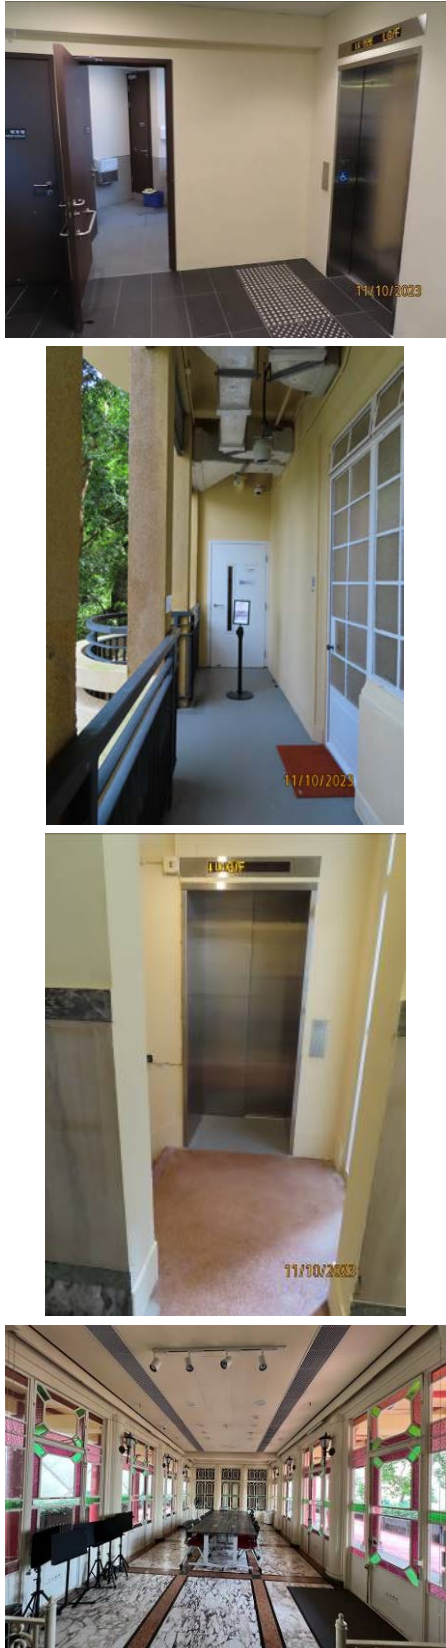
Item No.	Architectural Features to be Preserved and Conservation Guidelines	Photo
C.1	<p>(cont'd)</p> <p>convert the quarters into toilets.</p> <ul style="list-style-type: none"> - Conversion of the original kitchen at servants' quarters into office. - A new doorway was formed at G/F classroom (original dining room) to verandah facing the Garden to meet MOE requirement. - The space between the ceiling slab of penthouse on 2/F and the pitched roof was utilized to house air ducts and other services. <ul style="list-style-type: none"> ● Acoustic panel had been installed previously to meet users' requirement. Remove the acoustic panel and reinstate the affected historic building fabrics to reveal the original fabric as far as practicable. ● Restore the original furniture setting of some of the room(s) preserved for interpretation. ● Original architectural features including timber paneled door, ceramic wall and floor tiles, sanitary wares and fittings, skirting, metal-framed doors and windows, metal-framed fanlights, and timber parquet flooring and the like which have been salvaged due to changes made in the last revitalisation works were stored on-site for future use, and should be reused as far as practicable.

<p>The photo section contains four images: 1) A hallway with a dark door on the left and a glass-fronted elevator on the right. 2) A balcony with a dark metal railing and a white door at the end. 3) A close-up of an elevator shaft with a pinkish carpet in the foreground. 4) A long, bright dining room with a long table, chairs, and large windows with colorful frames.</p>

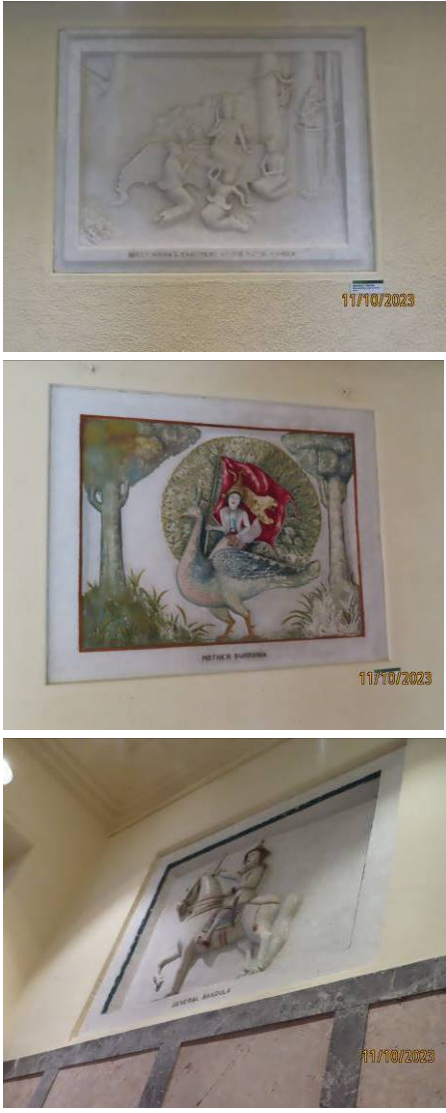
Item No.	Architectural Features to be Preserved and Conservation Guidelines	Photo
C.3	<p><u>Reliefs</u>⁴ on walls illustrating religious stories</p> <p>Required Treatments:</p> <ul style="list-style-type: none"> ● The reliefs on walls should be preserved in-situ ● Cleaned by using bristle or nylon brushes and clean water as necessary. Corrosive cleaning chemicals should not be used. ● The reliefs should be exposed for public appreciation. No covering up of the reliefs is permitted.

<p>The 'Photo' column contains three separate photographs of wall reliefs. The top photograph shows a white, rectangular relief of a seated figure with a child, set within a decorative frame. The middle photograph shows a colorful painting of a deity seated on a swan, also within a frame. The bottom photograph shows a relief of a deity riding a white horse, set within a frame. Each photograph has a yellow date stamp in the bottom right corner that reads '11/10/2023'.</p>

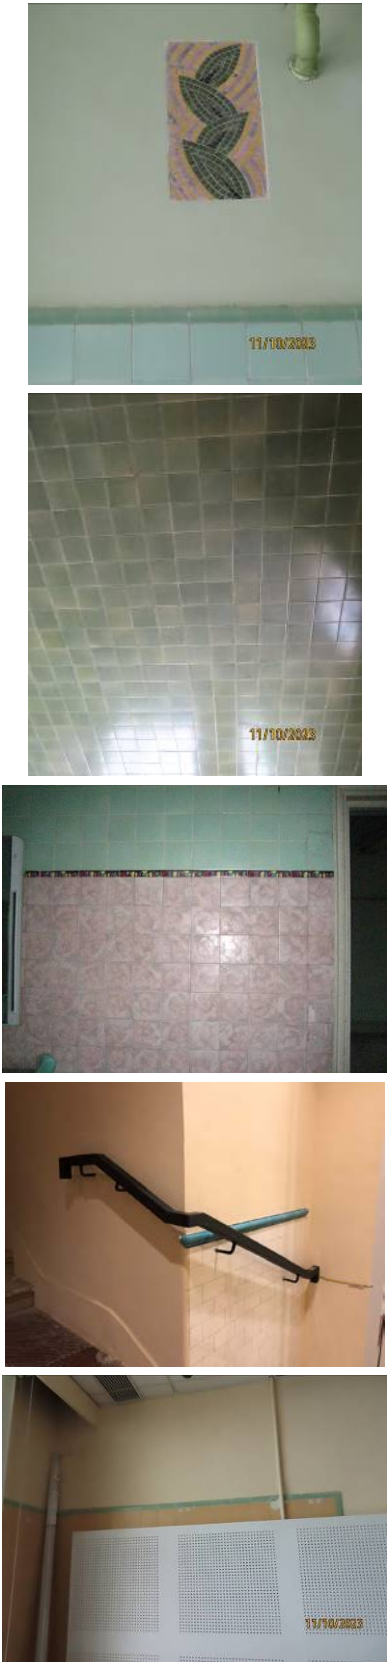
Item No.	Architectural Features to be Preserved and Conservation Guidelines	Photo
C.5	<p><u>Glazed ceramic featured dado, wall tiles and floor tiles with pattern in original bathrooms on G/F and 1/F, at staircase walls of LG/F (next to lift lobby) and original cold storage room on R/F</u></p> <p>Required Treatments:</p> <ul style="list-style-type: none"> ● All existing glazed tiles should be preserved in-situ. ● Repair and replacement of defective tiles with tiles of matching material, size, texture, colour and pattern of the existing tiles as necessary. ● No further removal or covering up of the existing glazed tiles unless with sound justification and subject to AMO’s approval. <p>Recommended Treatments</p> <ul style="list-style-type: none"> ● Acoustic panel were installed at the en-suite bathrooms of the southwest side bedrooms on 1/F previously to meet users’ requirement. Remove the acoustic panel and reinstate the affected wall tiles to reveal the original fabric as far as practicable.

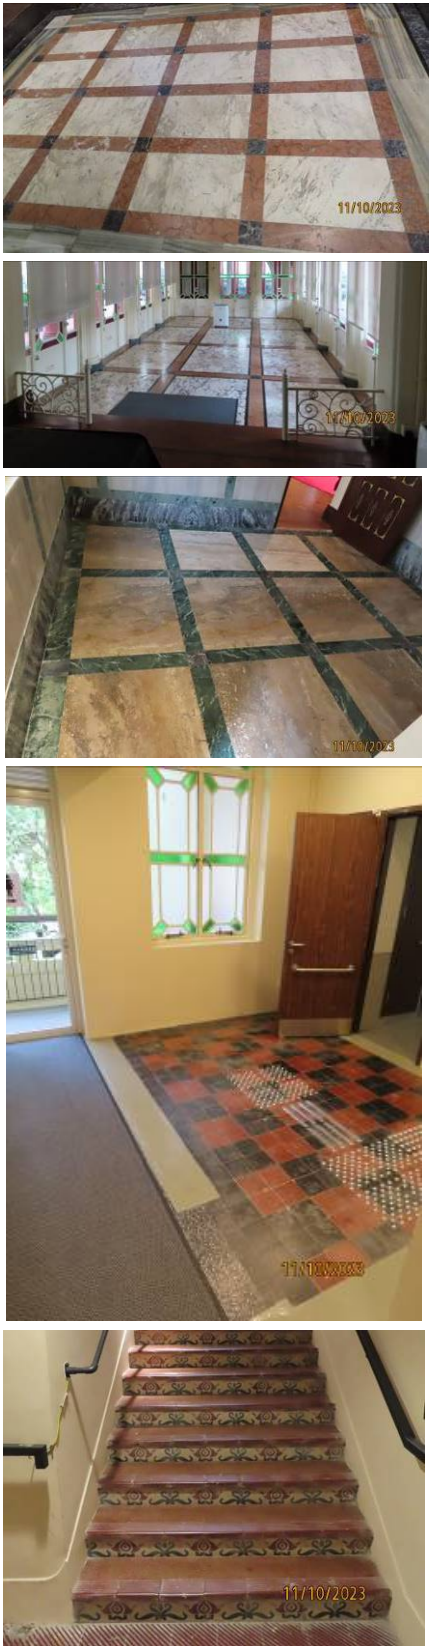
Item No.	Architectural Features to be Preserved and Conservation Guidelines	Photo
C.7	<p><u>Decorative floor finishes and skirting</u>, including marble flooring, patterned ceramic tiled flooring, ceramic hexagonal tiled flooring, fine terrazzo flooring, and encaustic ceramic tiled flooring (on the risers at steps leading to the original kitchen) etc.</p> <p>Required Treatments:</p> <ul style="list-style-type: none"> ● All original decorative floor tiles in the interiors of the building should all be preserved in-situ and cleaned with bristle or nylon brushes and clean water. Corrosive cleaning chemicals should not be used. ● For marbles and encaustic ceramic tiled flooring, repair cracks and make good finish to match with existing to an acceptable level by specialist as necessary. ● No damage and covering up of the marble flooring in anyway including any modification or localized strengthening works to the floor slabs unless with sound justification and subject to AMO’s approval. <p>Recommended Treatments:</p> <ul style="list-style-type: none"> ● Tactile paving has been provided at the patterned ceramic floor tiles in lift lobby during the last revitalisation works to meet the barrier-free access requirement. Reuse the later-added facilities as far as practicable to avoid further damage to the tiles. ● New handrails were installed at wall sides of staircase from LG/F to G/F during the last revitalisation works to meet barrier free access. Reuse the later-added facilities as far as practicable to avoid damage to the tiles. ● Some of the patterned ceramic tiled flooring was covered with carpet to meet users’ requirements during the last revitalisation works. Remove the carpet and reinstate the affected tiles to reveal the original fabric as far as practicable.

<p>The photo column contains four images. The top image shows a close-up of a marble floor with a grid pattern of dark lines. The second image shows a long, brightly lit hallway with patterned ceramic tiled flooring. The third image shows a lift lobby with patterned ceramic tiles and tactile paving. The bottom image shows a staircase with decorative ceramic tiles on the risers.</p>

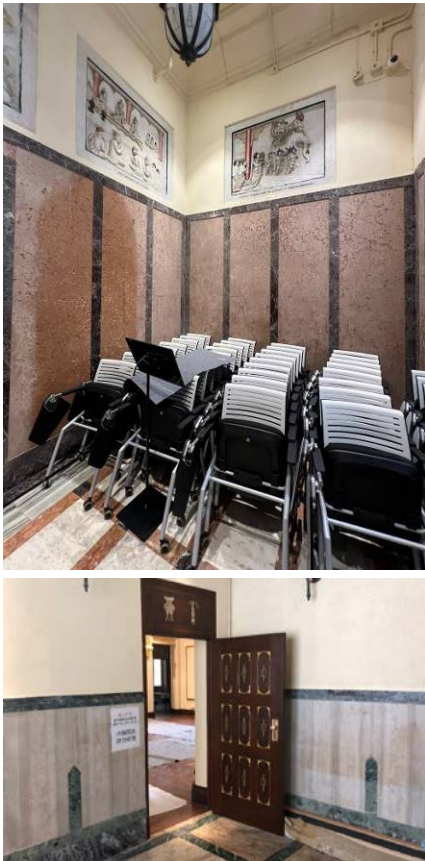
Item No.	Architectural Features to be Preserved and Conservation Guidelines	Photo
C.8	<p><u>Dado finished with marble</u> at original entrance porch and hallway on G/F to servants' quarters</p> <p>Required Treatments:</p> <ul style="list-style-type: none"> ● All marble finishes should be preserved in-situ and cleaned with bristle or nylon brushes and clean water. Corrosive cleaning chemicals should not be used. ● Repair cracks and make good finish to match existing to an acceptable level by specialist as necessary. ● No damage and covering up of the marble finishes in anyway unless with sound justification and subject to AMO's approval.

<p>The top photograph shows a room with walls finished with marble dado. The walls are light-colored with dark marble borders. There are rows of white plastic chairs with black frames. A framed picture hangs on the wall. The bottom photograph shows a doorway with a dark wooden door. The walls on either side of the doorway are finished with marble dado, showing a light-colored marble with dark borders. A small sign is visible on the wall to the left of the door.</p>

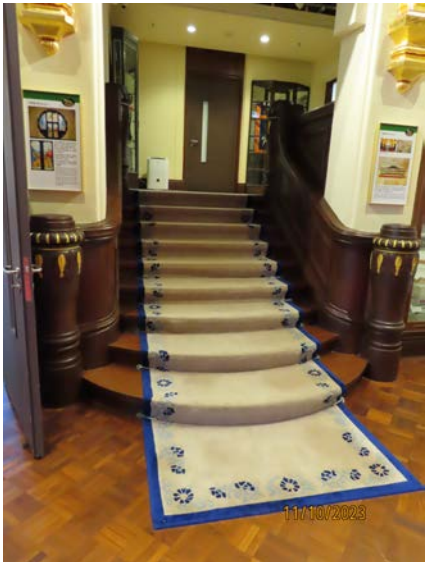
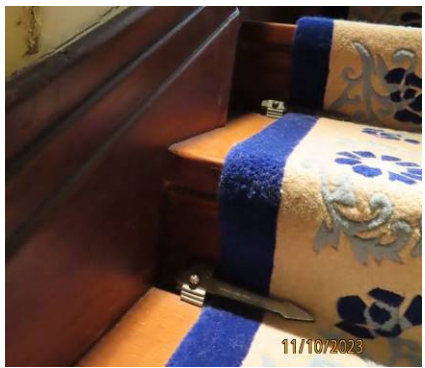
Item No.	Architectural Features to be Preserved and Conservation Guidelines	Photo
C.9	<p><u>Hardwood staircases</u>, including the timber stairs, timber paneled and geometric patterned balustrades with simple mouldings, timber handrails, newel posts and metal carpet pins etc.</p> <p>Required Treatments:</p> <ul style="list-style-type: none"> ● The hardwood staircase should be preserved in-situ. ● Any upgrading works of balustrades to meet the statutory requirements should be avoided as far as practicable to minimize disturbance to the hardwood staircase, subject to the approval of Buildings Authority. ● Timber balustrades, newel posts, and handrails should only be cleaned and re-finished with wood grain protective coating as necessary. ● The carpet pins on the steps should be preserved and re-used. ● Termite treatment (Refer to C.6) <p>Recommended Treatments:</p> <ul style="list-style-type: none"> ● Management approaches, including placing pot planters along the existing balustrades of the staircase at designated areas to prevent people from approaching the balustrade that is lower than 1.1m high, addition of handrails on the wall side of the staircase for MOE provision and the later-added carpet mitigating the old carpet were adopted to strike a balance between maintaining the architectural authenticity and complying with the statutory requirements in the previous statutory submission. ● Adoption of a similar management approaches as far as possible to preserve the existing balustrades and hardwood staircase in-situ are recommended.

<p>The carpet pins on steps</p>

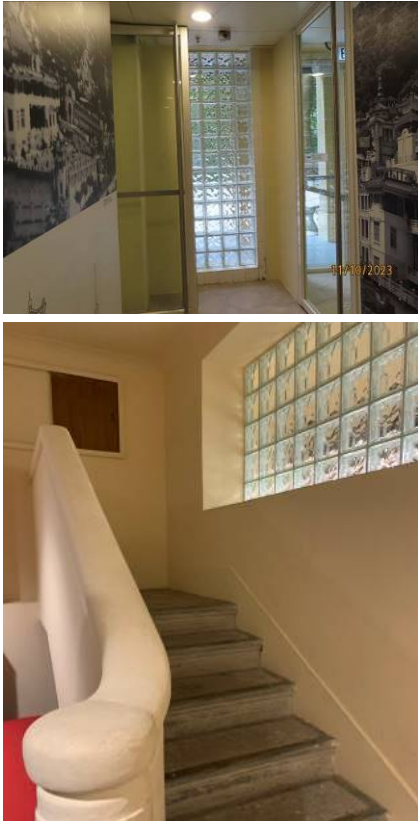
Item No.	Architectural Features to be Preserved and Conservation Guidelines	Photo
C.10	<p><u>Glass block screens</u> at lift lobby and besides Dish delivery stairs on LG/F</p> <p>Required Treatments:</p> <ul style="list-style-type: none"> ● The existing glass block screens preserved should be preserved in-situ. <p>Recommended Treatments:</p> <ul style="list-style-type: none"> ● There were original two glass block screens at the entrance on LG/F, one of the screens has been removed with the glass block salvaged during the last revitalisation works to meet the MOE requirement. Reuse and relocate those salvaged glass block in future could be considered.

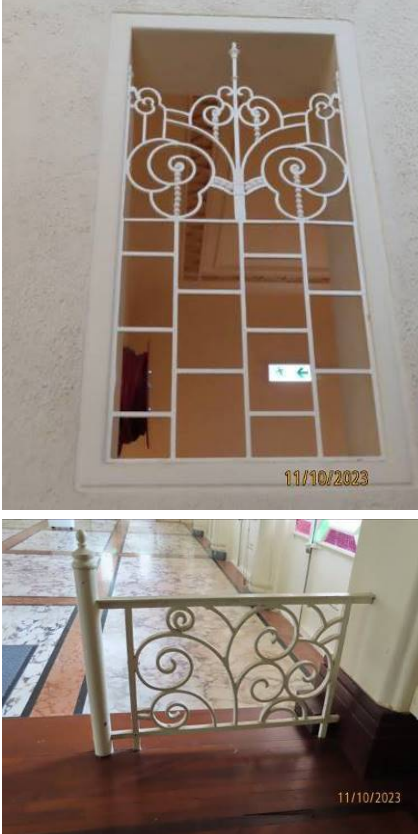
C.11	<p><u>The internal decorative metal grilles and balustrades</u> on G/F and R/F</p> <p>Required Treatments:</p> <ul style="list-style-type: none"> ● The decorative metal grilles and balustrades should be preserved in-situ, repaired, and repainted as necessary. <p>Recommended Treatments</p> <ul style="list-style-type: none"> ● A new glazed panel was installed behind the decorative metal grilles on G/F to meet protective barrier requirements. Reuse the later-added installation to avoid further damage to the historic building fabric as far as practicable.

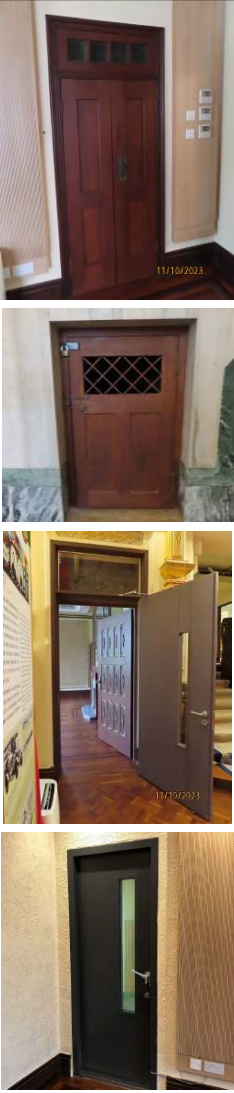
Item No.	Architectural Features to be Preserved and Conservation Guidelines	Photo
C.12	<p><u>Internal timber-framed doors</u>⁵, including timber paneled doors with or without decorations and the decorative wooden carvings and screens on top and the historic ironmongeries. Some of the door frames are carved with egg and darts motifs.</p> <p>Required Treatments:</p> <ul style="list-style-type: none"> ● The historic doors, door frames and ironmongeries should be preserved in-situ and repaired as necessary. ● Loosen defective timber parts on wood carvings should be refixed by specialist as necessary. ● Internal timber-framed door leaves and the door frames had been restored with wood grain colour during the last revitalisation. Repaint the defective protective coating with matching colour protective coating as necessary. ● Termite treatment (Refer to Item No. C.6) <p>Recommended Treatments:</p> <ul style="list-style-type: none"> ● New doors had been later-added to the doors of original dining room and study room on G/F to comply with the MOE requirements while preserving and allowing appreciation of the historic doors at the same location. Reuse the new doors as necessary to avoid further disturbance to the historic doors and fames. ● Some of the historic doors were taken down and replaced with fire-rated doors to meet fire safety requirement during the last revitalisation. Reuse the later-additions as necessary or consider restoration of original timber doors to its original locations in case of change of design in future.

Item No.	Architectural Features to be Preserved and Conservation Guidelines	Photo
C.12	<p>(cont'd)</p> <ul style="list-style-type: none"> Some of the historic doors were taken down and replaced with laminated doors for acoustic purpose during the last revitalisation works. Restore those doors with the original timber doors to reveal the historic appearance as far as practicable.

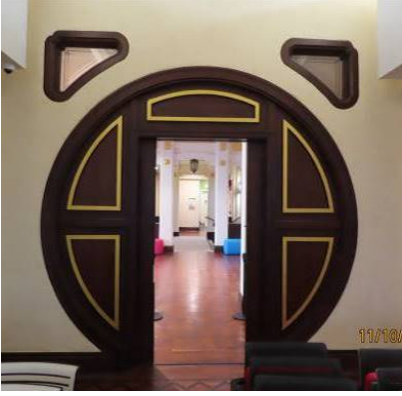
C.13	<p><u>Featured timber door</u>⁶ in a Chinese moon-gate style timber frame with side screens and above triangular glazed screens on 1/F.</p> <p>Required Treatments:</p> <ul style="list-style-type: none"> The featured timber door should be preserved in-situ. No modification works and removal work is permitted. It had been restored with wood grain colour during the last revitalisation. Repaint the defective protective coating with matching colour protective coating as necessary. Termite treatment (Refer to Item No. C.6)

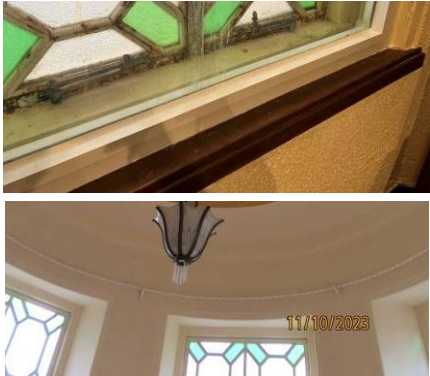
Item No.	Architectural Features to be Preserved and Conservation Guidelines	Photo
C.14	<p><u>Internal timber window sills, and steel curtain rails.</u></p> <p>Required Treatments:</p> <ul style="list-style-type: none"> ● Internal timber window sills and steel curtain rails should be preserved in-situ. ● The internal timber window sills were restored with wood grain colour during the last revitalisation works. Repair and paint the defective protective coating with matching colour protective coating as necessary. ● Repair and repaint the steel curtain rails to match with existing as necessary.

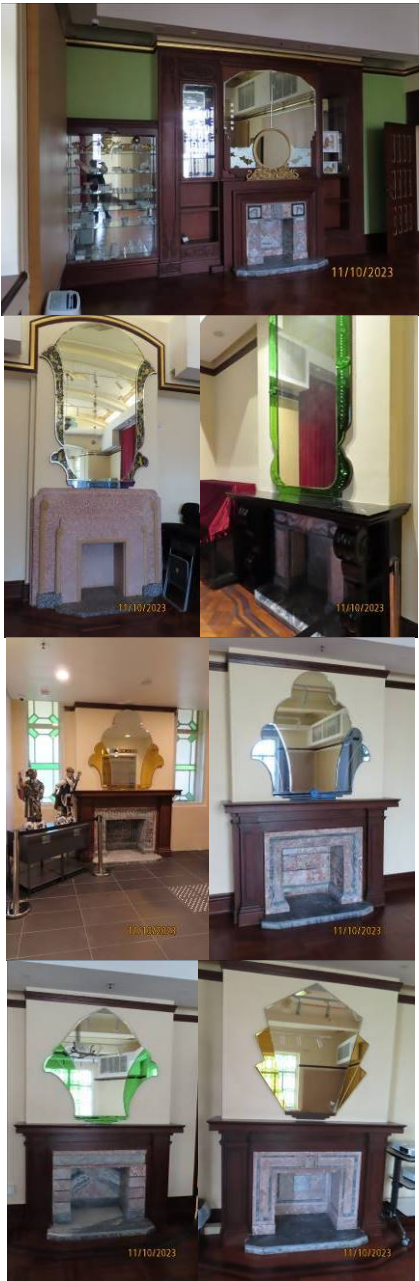
Item No.	Architectural Features to be Preserved and Conservation Guidelines	Photo
C.15	<p>All fireplaces⁷ with fire surrounds and hearths in painted timber, marble, or terrazzo finishes of Italianate-inspired design, and wall mirrors⁸ on top or in associated cabinet.</p> <p>Required Treatments:</p> <ul style="list-style-type: none"> ● All fireplaces should be preserved in-situ and repaired by specialists with materials, profile, colour and texture matching with existing as necessary. ● Do not cover the fireplaces. ● Mirrors on top of fireplaces should be preserved in-situ.
