Conservation Guideline

The site of the project (the “Site”) is located at 15A Tai Hang Road, Wan Chai, Hong Kong. The Location Plan is shown at **Appendix II**.

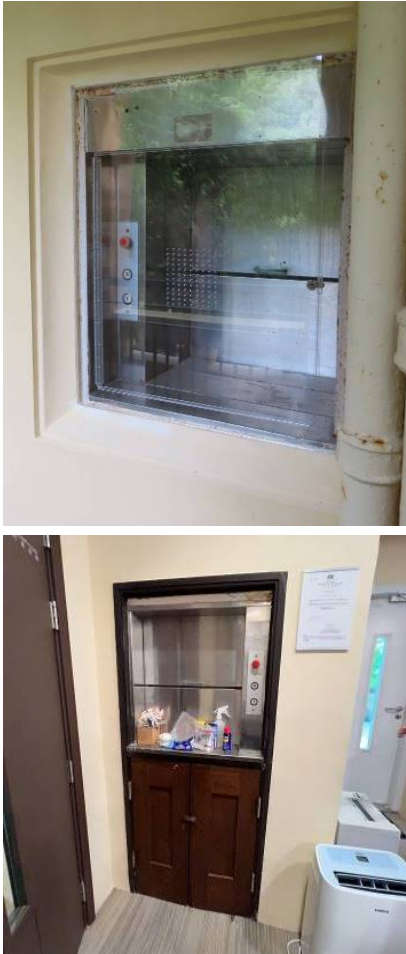
Item No.	Architectural Features to be Preserved and Conservation Guidelines	Photo
C.16	<p><u>Dumb waiter with its opening on each floor and built-in timber cabinet</u> with frame and panel doors at lower ground floor kitchen.</p> <p>Required Treatments:</p> <ul style="list-style-type: none"> ● The remained dumb waiter, its openings, the shaft and the cabinet with frame should be preserved in-situ. ● The cabinet should be repaired and repainted to match with the existing. ● Termite treatment of the timber cabinet (Refer to Item No. C.6) <p>Recommended Treatments</p> <ul style="list-style-type: none"> ● Glazed panel and fire barrier were installed at the dumb waiter openings and shaft to meet fire safety and users' requirements. Reuse the later-added installations to avoid further damage to the historic building fabric as far as practicable.

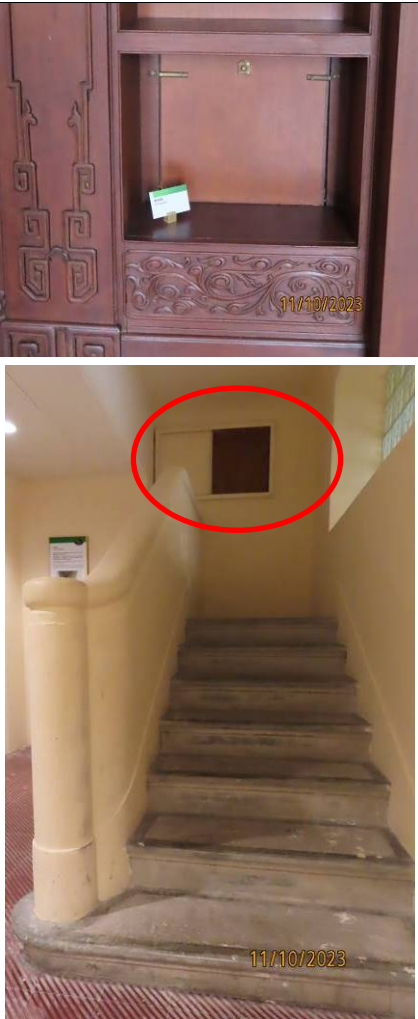
Item No.	Architectural Features to be Preserved and Conservation Guidelines	Photo
C.17	<p><u>Dish delivery passage</u> linking the original dining room on ground floor to the kitchen on lower ground floor including the Dish Delivery Staircase and its balustrades.</p> <p>Required Treatments:</p> <ul style="list-style-type: none"> ● The passage and the openings with the wooden paneled doors at both ends should be preserved in-situ and should not be blocked or covered up for interpretation purposes. ● Repair and repaint the defective area of the balustrades and wooden paneled to match existing as necessary. ● Termite treatment (Refer to Item No.C.6) <p>Recommended Treatments:</p> <ul style="list-style-type: none"> ● Using management approach of restricted access to the Dish Delivery Staircase for interpretation only was adopted to strike a balance between maintaining the architectural authenticity and complying with the statutory requirements in the previous statutory submission ● Adoption of a similar management approach as far as possible to avoid any alteration work to the Dish delivery staircase is recommended.

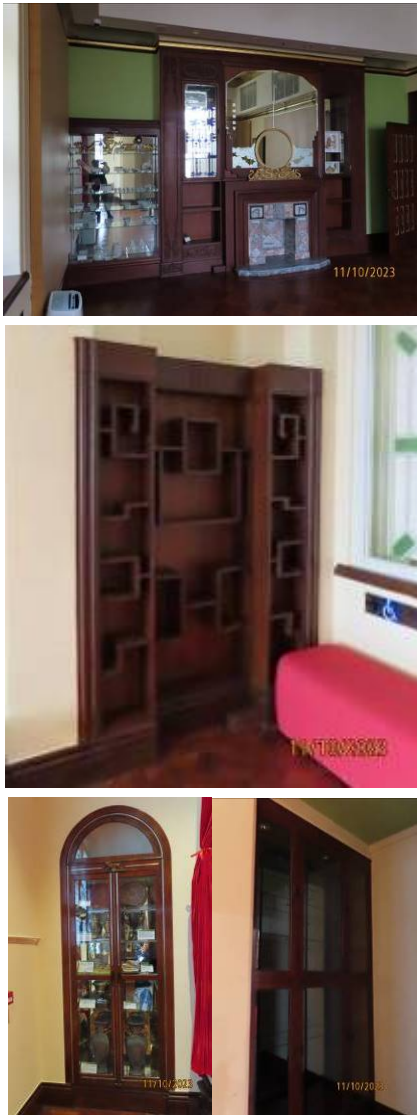
Item No.	Architectural Features to be Preserved and Conservation Guidelines	Photo
C.18	<p><u>Built-in fixtures and furniture</u>⁹, including architraves with decorative fixtures, built-in display cabinets and the decorative panels on top, some with the Haw Par/ HP emblems or with images of tigers or leopards, walk-in closet and all timber paneled walls and all historic ironmongeries etc.</p> <p>Required Treatments:</p> <ul style="list-style-type: none"> ● All original built-in fixtures and furniture and its ironmongeries should be preserved in-situ and repaired with materials, design and colour to match with existing as necessary. ● Loosen defective timber parts on wood carvings should be refixed by specialist as necessary. ● The built-in timber fixtures and furniture had been restored with wood grain colour during the last revitalisation. Repaint the defective protective coating with matching colour protective coating as necessary. ● Termite treatment (Refer to Item No. C.6)

<p>The photo section contains three images. The top image shows a large, dark wood display cabinet with glass doors and a decorative arched top, containing various items. The middle image shows a similar cabinet with open shelving and a pink cushioned bench in front of it. The bottom image is a close-up of a glass-fronted cabinet with a decorative top and a red tassel hanging nearby.</p>

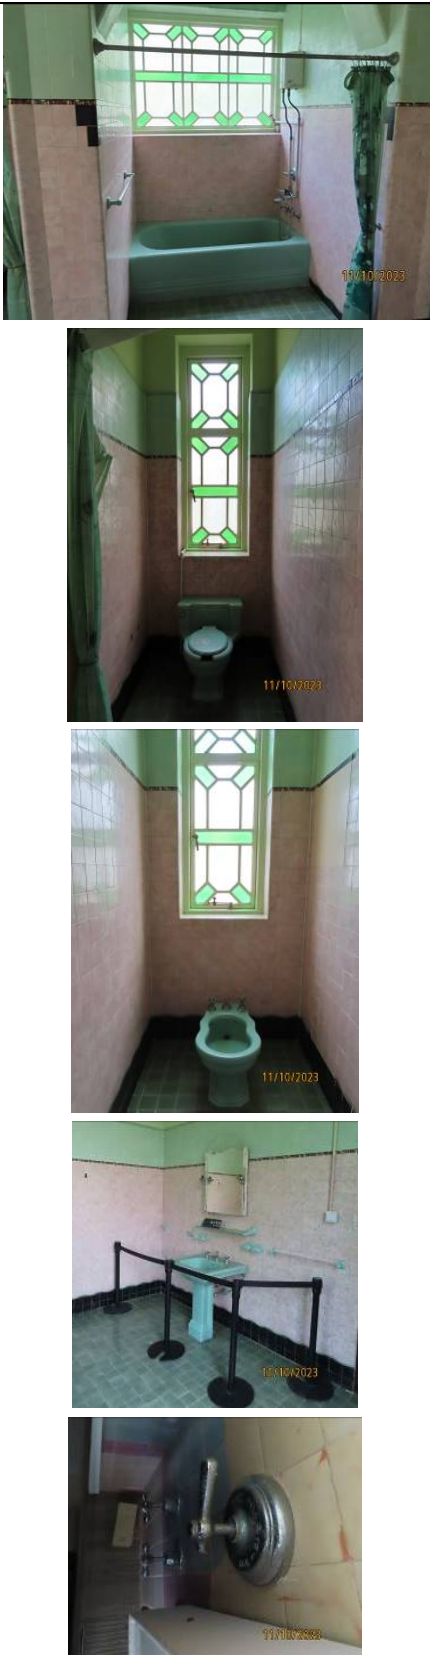
Item No.	Architectural Features to be Preserved and Conservation Guidelines	Photo
C.19	<p><u>Sanitary wares and fittings</u></p> <p>Required Treatments:</p> <ul style="list-style-type: none"> ● The original bathroom of the master bedroom with its original setting, sanitary wares, fittings and finishes should be preserved in-situ for interpretation. ● The historic faucets remain on walls of original 1/F southwest en-suite bathrooms after the last revitalisation works should be preserved in-situ unless with sound justification and subject to AMO’s approval. <p>Recommended Treatments:</p> <ul style="list-style-type: none"> ● Some of the ceramic sanitary wares and fittings were removed in the last revitalisation works. Reuse or display the salvaged sanitary wares and fittings and restore to its original locations could be considered in case of change of design in future.

<p>The photo section contains five images: 1. A bathtub in a bathroom with a window above it. 2. A toilet in a bathroom with a window above it. 3. A pedestal sink in a bathroom with a window above it. 4. A close-up of a faucet on a wall. 5. A close-up of a faucet on a wall.</p>

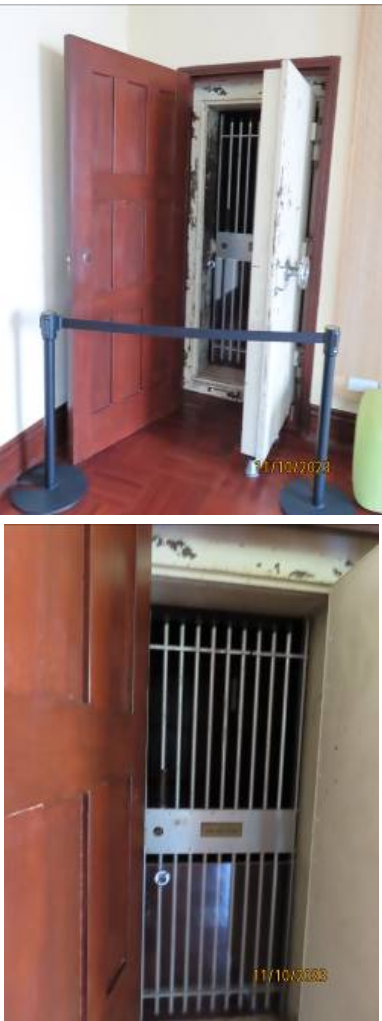
Item No.	Architectural Features to be Preserved and Conservation Guidelines	Photo
C.20	<p><u>Security Room including a built-in safe</u> in master bedroom on 1/F including the safe door, the metal gate, the paneled walls and the shelves.</p> <p>Required Treatments:</p> <ul style="list-style-type: none"> ● The security room, including a built-in safe with metal gate and its door, the paneled walls and the shelves should be preserved in-situ. ● The configuration of the room should not be altered <p>Recommended Treatments:</p> <ul style="list-style-type: none"> ● Using management approach of restricted access to the Security Room for maintenance only but allow appreciation from the outside was adopted in order to exempt from installation of sprinkler inside the room in the previous statutory submission ● Adoption of a similar management approach as far as possible to avoid further alteration work to the Security Room is recommended.

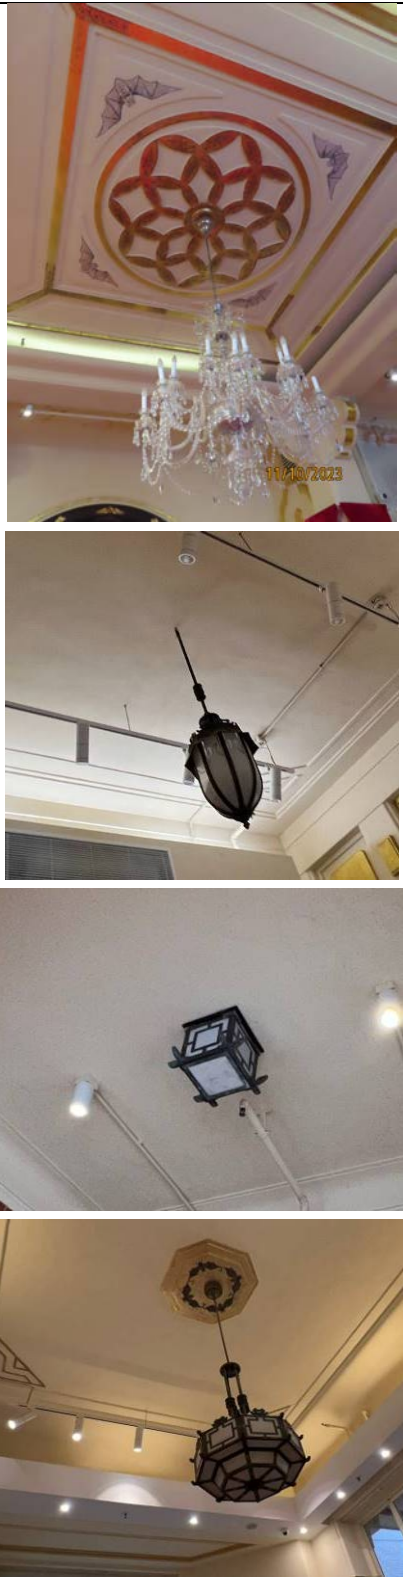
Item No.	Architectural Features to be Preserved and Conservation Guidelines	Photo
C.21	<p><u>Antique light fittings¹⁰, including pendant lamps, ceiling mount light, and the parts etc.</u></p> <p>Required Treatments:</p> <ul style="list-style-type: none"> ● The antique light fittings which had been restored to the original locations during the last revitalisation works for display should be preserved in-situ. ● Repair the defective parts of antique light fittings by specialist as necessary. <p>Recommended Treatments:</p> <ul style="list-style-type: none"> ● Some of the antique light fittings had been salvaged and stored on-site. Further historic research should be carried out to identify the original locations. Repair and restore to its original location for display or reuse the salvaged antique light fittings as far as practicable.

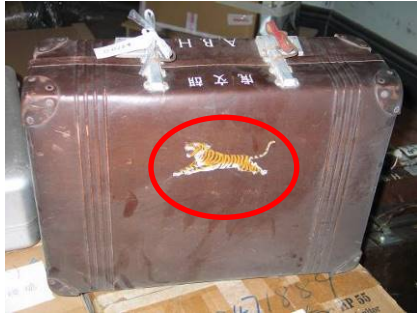
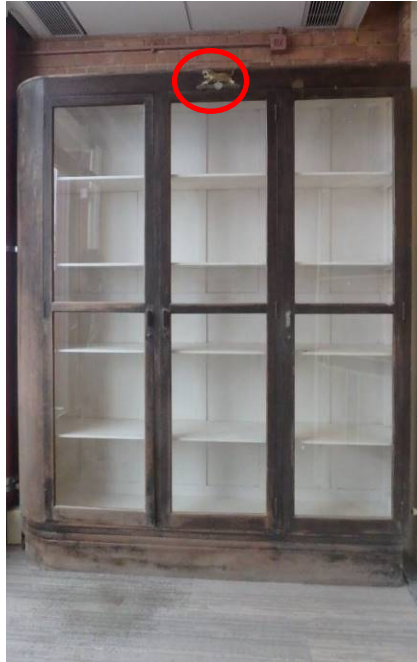
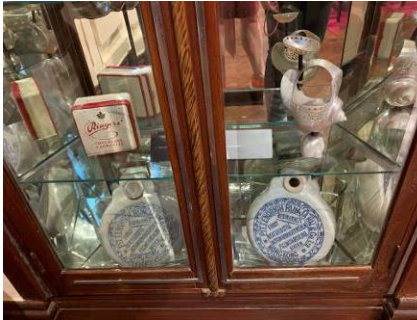
Item No.	Architectural Features to be Preserved and Conservation Guidelines	Photo
C.22	<p><u>Historic items and movable furniture¹¹</u>, including display cabinets, dressing tables, coffee tables, chairs, mirrors, and other movable furniture etc. Besides, the carpet and movable furniture on display.</p> <p>Recommended Treatments:</p> <ul style="list-style-type: none"> ● The historic items and movable furniture should be preserved on site. ● Select some of the historic items and movable furniture from the storage for display within the Mansion. Repair and restore the selected historic items and movable furniture by specialist as necessary. ● Except where otherwise stated, all furniture and historic items bearing a “HP” emblem, image of a tiger or leopard, or any other form of description of “Haw Par” or Aw’s family¹¹ are recommended to be retained for use and/or display within the Mansion. ● Termite treatment (Refer to Item No. C.6)

<p>Furniture and artefact with image of tigers</p>

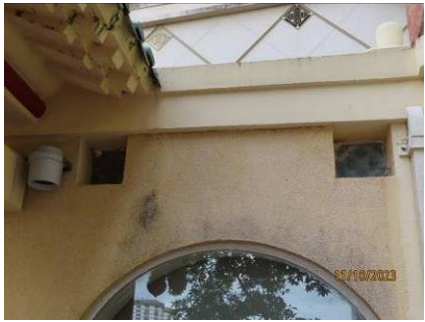
Item No.	Architectural Features to be Preserved and Conservation Guidelines	Photo
C.23	<p><u>Ceramic grilles</u>¹² at the penthouse</p> <p>Required Treatments:</p> <ul style="list-style-type: none"> ● The existing ceramic grilles should be preserved in-situ without covering them except by glass to suit new use. <p>Recommended Treatments:</p> <ul style="list-style-type: none"> ● Two of the grilles were taken down and salvaged during the last revitalisation works for passing of building services. Reinstate the opening with ceramic grilles if passing through of building services is not required in future.

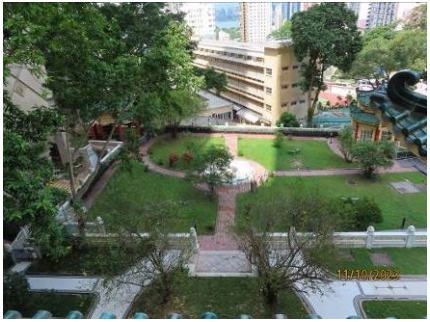
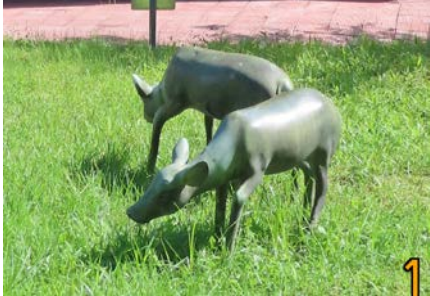
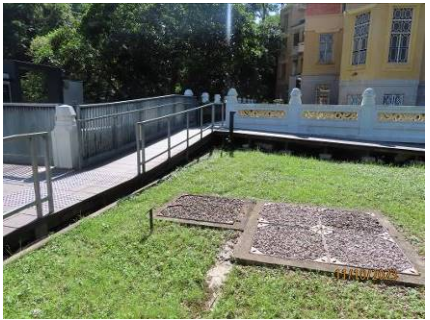
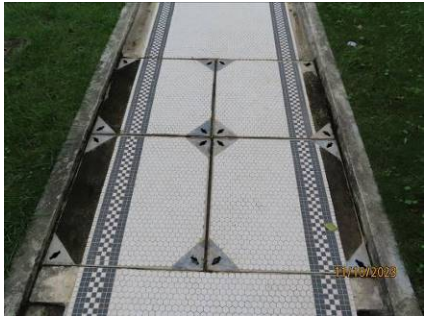
Item No.	Architectural Features to be Preserved and Conservation Guidelines	Photo
D.1	<p><u>The setting and layout of the Garden</u>, including the footpaths, mosaic walkway, the fountain, all fence walls, sculpture and all the plantations such as trees, shrubs, grass, and pot plants etc.</p> <p>Required Treatments:</p> <ul style="list-style-type: none"> ● The original two-tier setting and the garden layout should be preserved in-situ, and its openness should be kept. ● All the plants should be preserved in-situ unless permitted by AMO. A detailed horticultural survey should be carried out to identify the species and check the health condition of all the plantations. Transplanting or replacement of plantations might only be permitted with sound justification, e.g. health considerations. ● The sculptures inside the Garden should be properly maintained, preserved and captioned. They should be repaired as necessary, and the repair method should be submitted for AMO’s approval. ● Any proposal of improvement works and landscape work in Garden including upgrading of underground building services should be submitted to AMO for approval. <p>Recommended Treatments:</p> <ul style="list-style-type: none"> ● Alteration and addition works had been carried out previously to meet the modern-day requirements. Reuse the later-added facilities as far as possible to avoid further disturbance to the historic fabric. ● Check for proper operation and repair as necessary: <ul style="list-style-type: none"> – New outdoor ramps for connecting the two levels of Garden and from the footbridge to the Garden was constructed to meet barrier free requirement. – Introduction of building services routing into the Garden serving the Garden and the Mansion with new inspection pits covered by matching covers at the lawn and footpaths.

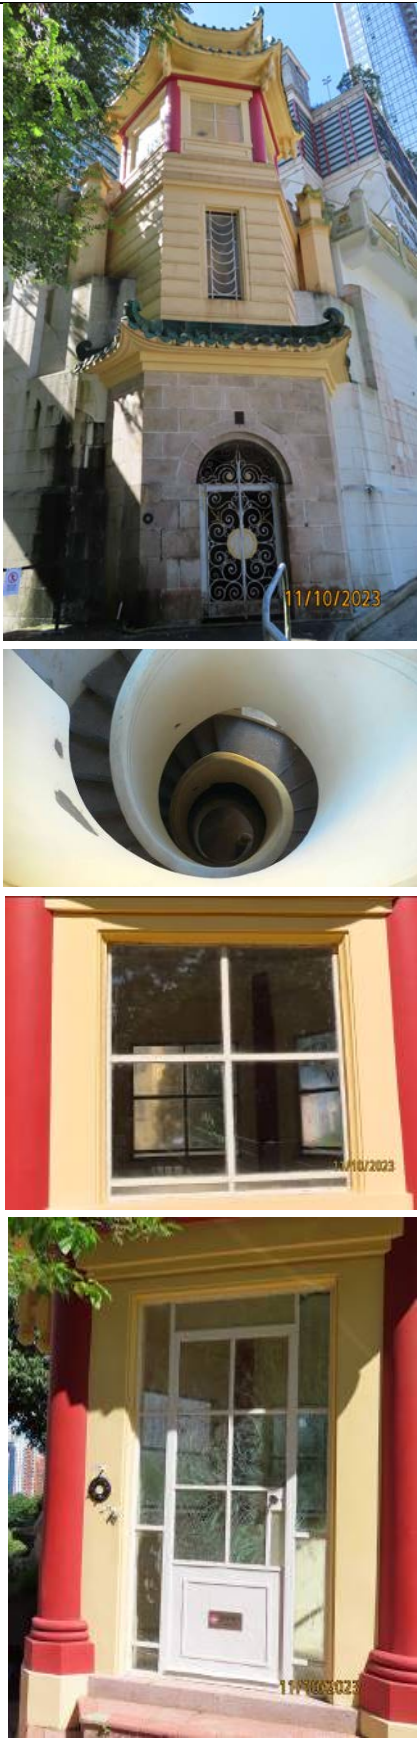
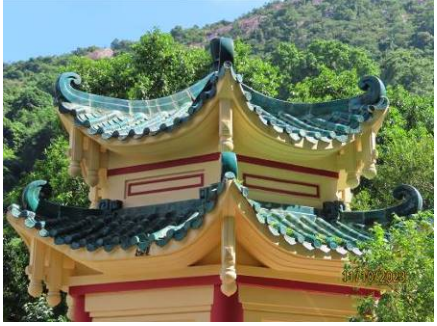
Item No.	Architectural Features to be Preserved and Conservation Guidelines	Photo
D.2	<p>The <u>Corner Tower</u> with granite base, Chinese-tiled roof and structural support including columns, beams, brackets, and decorative plasterwork, an internal spiral staircase, metal framed windows with plain or patterned and obscured/ colour glass panes, and metal glass doors with hand-painting.</p> <p>Required Treatments:</p> <ul style="list-style-type: none"> ● Chinese glazed-tiled roofs treatment (Refer to B.2). ● Building facades treatment (Refer to B.1). ● Metal framed windows and doors treatment (Refer to B.10) ● The whole Corner Tower including spiral staircase inside and the mentioned architectural features should be preserved in-situ. ● No addition and alteration work to the Corner Tower is allowed. All repair works should be carried out on a like-for-like basis with materials, colour, and design matching with the existing. ● Cracks found on the Corner Tower should be repaired to prevent further deterioration. Any repair and strengthening work proposed as necessary should not induce visual impact on the Corner Tower and should be submitted to AMO for approval. <p>Recommended Treatments:</p> <ul style="list-style-type: none"> ● The original stained glass panes on the metal framed windows now stored on-site should be repaired and restored in their original locations by a glazing specialist as far as practicable. All repair and reinstatement methods should be submitted to AMO for approval. ● Using management approach of restricted access to Corner Tower for maintenance only was adopted to strike a balance between maintaining the architectural authenticity and complying with the statutory requirements in the previous statutory submissions.

Item No.	Architectural Features to be Preserved and Conservation Guidelines	Photo
D.2	<p><i>(cont'd)</i></p> <ul style="list-style-type: none">● Adoption of a similar management approach as far as possible to avoid alteration to the Corner Tower is recommended.

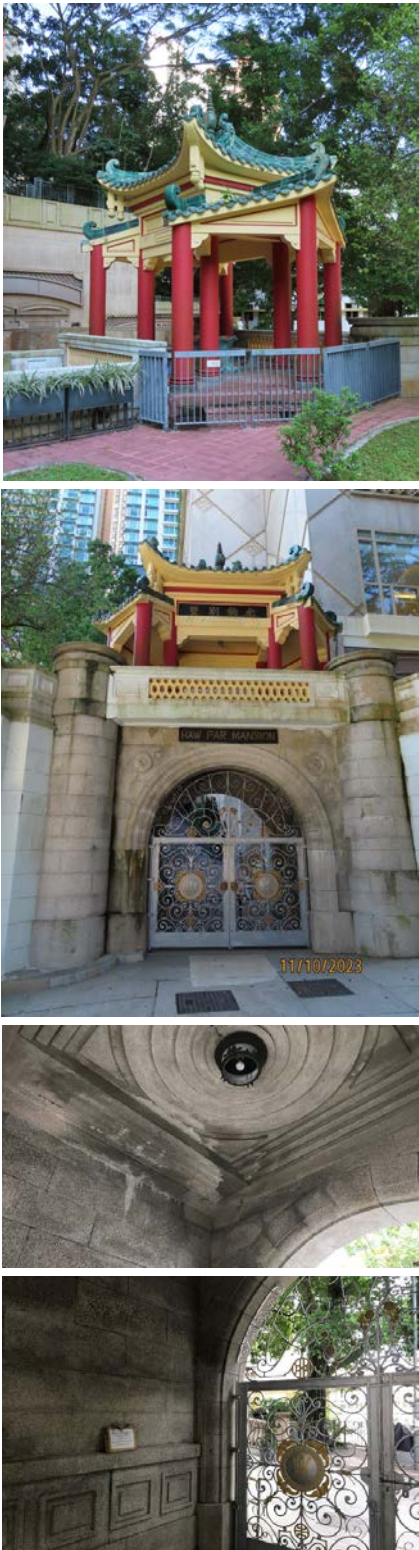
Item No.	Architectural Features to be Preserved and Conservation Guidelines	Photo
D.3	<p>The <u>Pavilion</u> with Chinese-tiled roofs, original red-painted plaster columns, terrazzo and quarry tiled floor finishes and the <u>granite entrance portal under the Pavilion</u> including the building signages inscribed with “HAW PAR MANSION” & “虎豹別墅”, Shanghai plaster finishes, all moulding features and historic light fittings, etc.</p> <p>Required Treatments:</p> <ul style="list-style-type: none"> ● Chinese glazed-tiled roofs treatment (Refer to B.2). ● Building facades treatment (Refer to B.1). ● The whole Pavilion and the granite entrance portal under the Pavilion including the mentioned architectural features should be preserved in-situ. ● No addition and alteration work to the Pavilion and the granite entrance portal is allowed. All repair works should be carried out on a like-for-like basis with materials, colour, and design matching with the existing. ● The exposed shanghai plaster finishes at the entrance portal should not be painted. <p>Recommended Treatments:</p> <ul style="list-style-type: none"> ● Using management approach of restricted access to the pavilion for maintenance only but allow appreciation from the outside with erection of new metal barrier at the Garden, was adopted to strike a balance between maintaining the architectural authenticity and complying with the statutory requirements in the previous statutory submission. ● Adoption of a similar management approach as far as possible to avoid further alteration to the Pavilion is recommended.

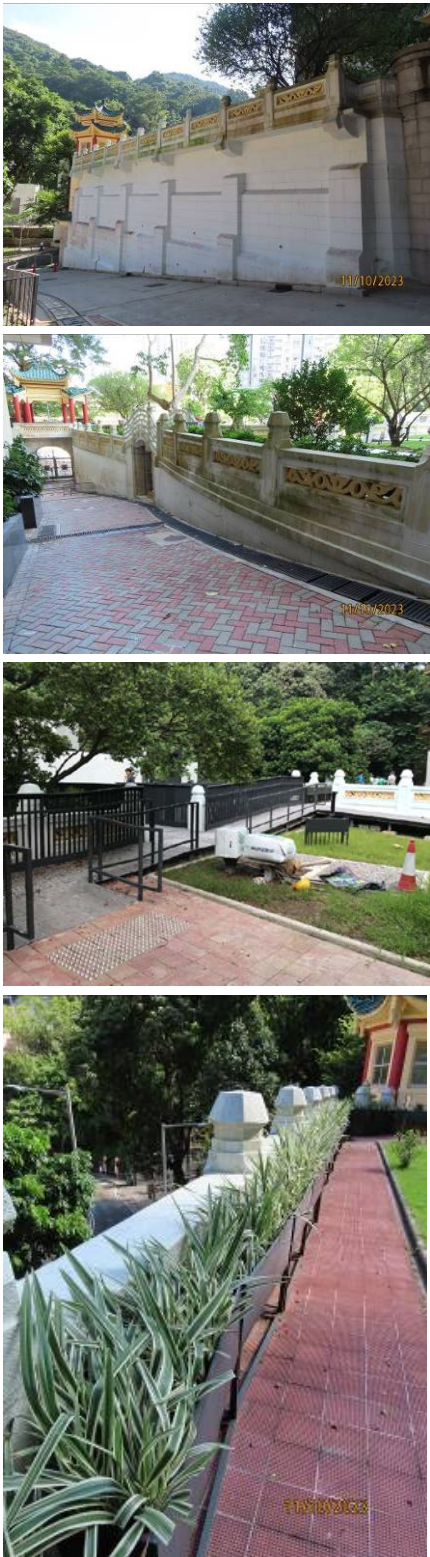
Item No.	Architectural Features to be Preserved and Conservation Guidelines	Photo
D.4	<p><u>Low boundary fence walls</u> with decorative balustrades and posts in painted shanghai plaster finishes.</p> <p>Required Treatments:</p> <ul style="list-style-type: none"> ● The low boundary fence walls should be preserved in-situ. Alteration to the low boundary walls is not allowed unless with sound justification and subject to AMO’s approval. ● Repair the low boundary fence walls with materials and colour matching with the existing. Dirt, stain and mould on the fence walls should be cleaned with bristle or nylon brushes and clean water; corrosive cleaning chemicals should not be used. ● Application of additional painting layers on the low boundary fence walls should be avoided such that the texture of the original shanghai plaster finishes underneath would not be covered. <p>Recommended Treatments:</p> <ul style="list-style-type: none"> ● Alteration and addition works had been carried out previously to meet the modern-day requirements. Reuse the new opening and later-added facilities as far as possible to avoid further disturbance to the historic fabric. ● Check for proper operation and repair as necessary: <ul style="list-style-type: none"> – A section of original low boundary fence wall was removed for the connection of footbridge to provide barrier free access from street level. – Additional balustrades were added in front of the low boundary fence wall at the northeast side of lower tier of Garden to meet the protective barrier requirement. ● Using management approach of placing pot planters in front of the other low boundary fence walls to prevent people from approaching the balustrade that is lower than 1.1m high, was adopted to strike a balance between maintaining the architectural authenticity and complying

Item No.	Architectural Features to be Preserved and Conservation Guidelines	Photo
D.4	<p><i>(cont'd)</i></p> <p>with the statutory requirements in the previous statutory submission.</p> <ul style="list-style-type: none">● Adoption of a similar management approach as far as possible to preserve the existing low boundary fence walls in-situ is recommended.

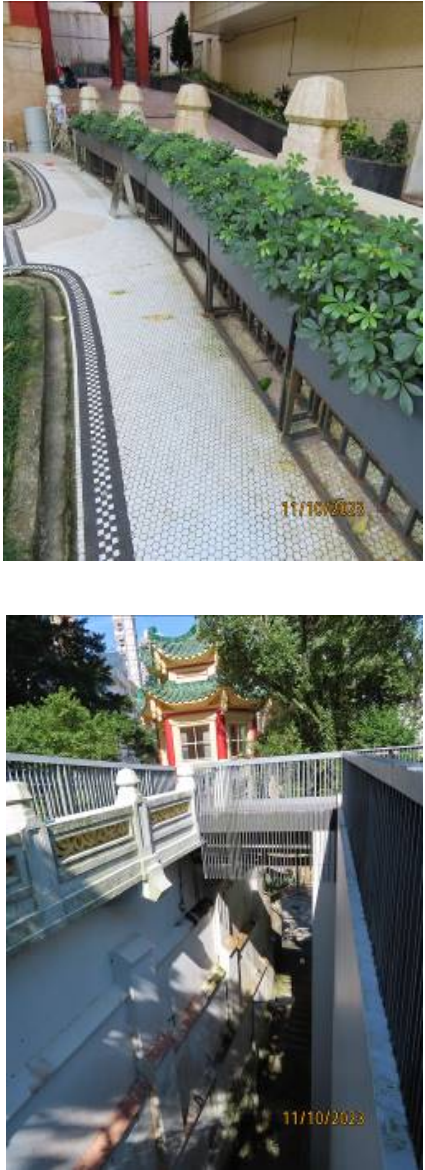
<p>The top photograph shows a paved walkway with a decorative border of small, light-colored tiles. To the right of the walkway is a low, dark-colored boundary fence with a metal railing. The fence is topped with green plants. A date stamp '11/18/2023' is visible in the bottom right corner of the photo.</p> <p>The bottom photograph shows a white, ornate stone railing with a metal fence in the foreground. In the background, there is a traditional Chinese building with a red facade and a green roof with yellow accents. A date stamp '11/10/2023' is visible in the bottom right corner of the photo.</p>

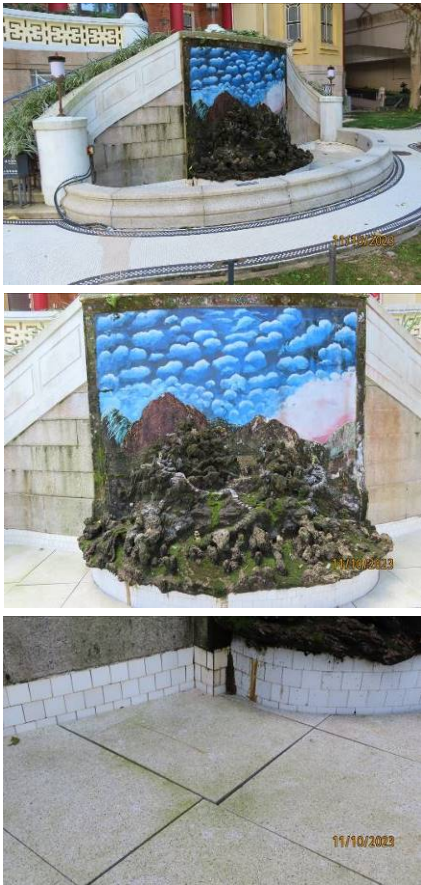
Item No.	Architectural Features to be Preserved and Conservation Guidelines	Photo
D.5	<p><u>The Pond</u> with a stone sculpture projected from the front face of the Palladian staircase inscribed with mural painting including the original white tiled finishes.</p> <p>Required Treatments:</p> <ul style="list-style-type: none"> ● The whole pond including the mentioned architectural features should be preserved in-situ. ● The stone sculpture should be cleaned with bristle or nylon brushes and clean water; corrosive cleaning chemicals must not be used. ● All white tiled finishes should be preserved in-situ and repaired as necessary. ● Grey new tiles had been added to the bottom of the pond to improve the appearance during the last revitalisation works. No objection to keep those new tiles but new tiles should be laid in a reversible manner such that the original white tiled finishes underneath should not be damaged. ● Clear any blockage and make sure the drainage is functioned properly. ● Any repair and restoration proposal should be submitted to AMO for approval. <p>Recommended Treatments:</p> <ul style="list-style-type: none"> ● The cloud background of mural painting is not original. Further historic research on the original painting background should be carried out. ● Keep the existing mural background, unless historic reference of the original appearance is available and restoration work to the original mural painting background by specialist with relevant experiences could be considered.

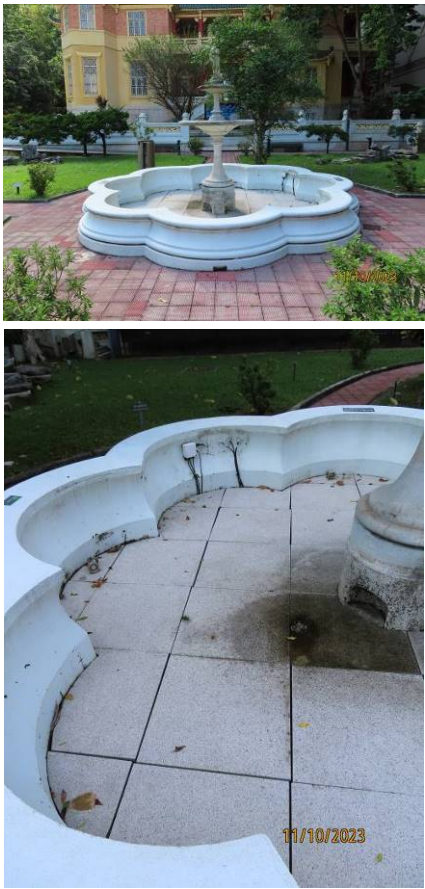
Item No.	Architectural Features to be Preserved and Conservation Guidelines	Photo
D.6	<p><u>The Fountain</u> with pool surround of floral pattern, two-tiered bowls and stone sculpture at the centre.</p> <p>Required Treatments:</p> <ul style="list-style-type: none"> ● The Fountain is one of the important decorative features in the Garden. It should be preserved in-situ, overhauled, and cleaned. ● Maintain the water circulating function of the fountain. ● Stone sculpture should be cleaned with bristle or nylon brushes and clean water; corrosive cleaning chemicals must not be used. ● Clear any blockage and make sure the drainage is functioned properly. ● Repair and repaint the pool surrounds with materials, design and colour match with the existing as necessary. <p>Recommended Treatments:</p> <ul style="list-style-type: none"> ● The original pumping system had been broken down, new pumping system was installed with new tiling cover in a reversible manner during the last revitalisation works. Reuse the new pumping system as far as practicable to minimize disturbance to the historic fabric.

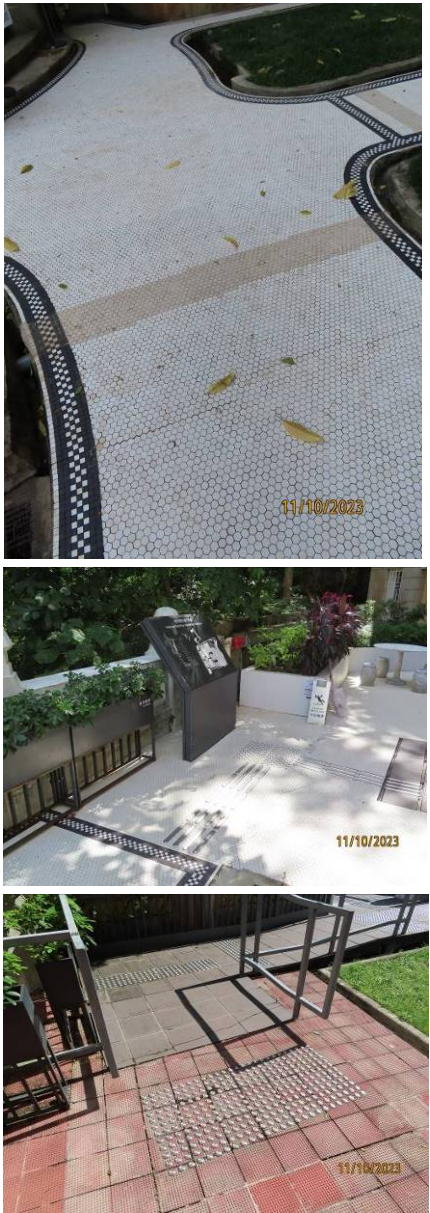
Item No.	Architectural Features to be Preserved and Conservation Guidelines	Photo
D.7	<p><u>Steps and footpath finished with patterned and plain mosaic floor tiles and red quarry tiles at the Garden.</u></p> <p>Required Treatments:</p> <ul style="list-style-type: none"> ● All mosaic floor tiles and red quarry tiles should be preserved in-situ and repaired as necessary. ● Reinststate any missing tiles with tiles of size, colour and pattern matching with the existing. ● Clean with bristle or nylon brushes and clean water as necessary. Corrosive cleaning chemicals should not be used. <p>Recommended Treatments:</p> <ul style="list-style-type: none"> ● Tactile warning strips have been provided from the landscape deck of services block through the ramp and footpath of the Garden to the entrance lobby of the Mansion to meet barrier free requirement. ● Reuse the tactile warning strips to minimize further disturbance to the mosaic tiles and red quarry tiles. ● Replace or update the directional plaque with tactile to facilitate visitors with disabilities to visit HPM as necessary.

<p>The 'Photo' column contains three vertically stacked images. The top image is a close-up of a mosaic tile path with a tactile warning strip. The middle image shows a wider view of the path with a tactile strip and a directional plaque. The bottom image shows a close-up of a red quarry tile path with a tactile strip. Each image has a date stamp '11/10/2023' in the bottom right corner.</p>

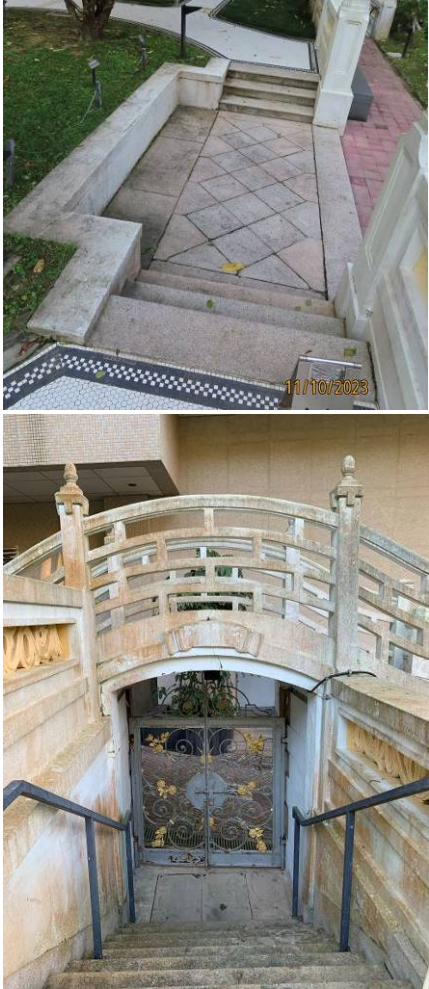
Item No.	Architectural Features to be Preserved and Conservation Guidelines	Photo
D.8	<p><u>Granite steps and paving in geometric pattern</u></p> <p>Required Treatments:</p> <ul style="list-style-type: none"> ● The granite steps and paving should be preserved in-situ. ● Clean with bristle or nylon brushes and clean water as necessary. Corrosive cleaning chemicals should not be used. <p>Recommended Treatments:</p> <ul style="list-style-type: none"> ● New handrails were installed at both sides of the granite stairs under the arched walkway to meet barrier free requirement. Reuse the new handrails to avoid further damage to the granite steps.

<p>The top photograph shows a set of granite steps and paving with a geometric diamond pattern. A date stamp '11/10/2023' is visible in the bottom right corner. The bottom photograph shows the same steps leading up to an arched walkway with new blue handrails installed on both sides.</p>

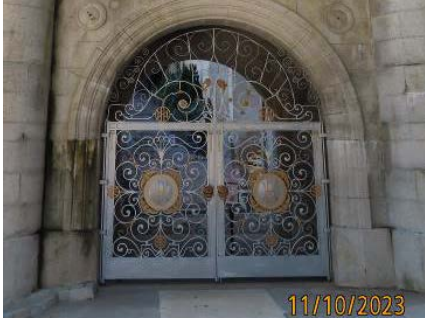
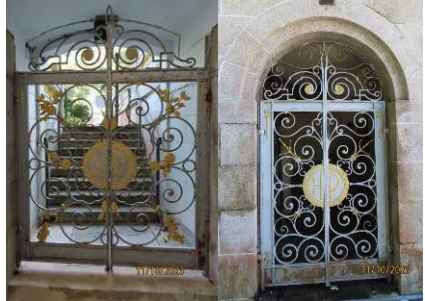
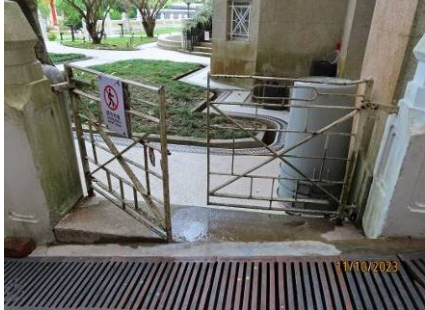
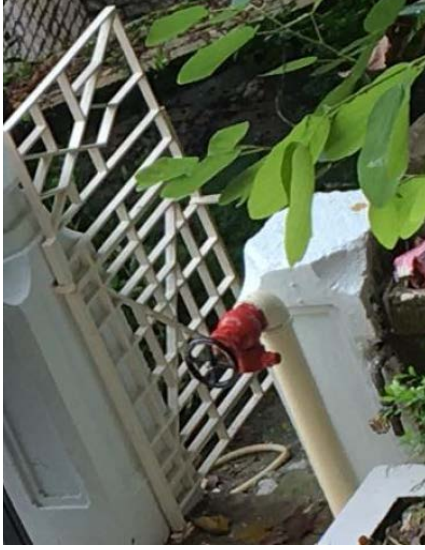
Item No.	Architectural Features to be Preserved and Conservation Guidelines	Photo
D.10	<p><u>Three pairs of ornamented entrance metal gates</u>, namely the Main Entrance Gate, the Main Garden Gate, and the Corner Tower Entrance Gate at street level, and the <u>two nos. of side metal gates</u> including the Side Garden Gate and Side Gate to Slope at northwest side.</p> <p>Required Treatments:</p> <ul style="list-style-type: none"> ● All these metal gates, of which three bear the logo of “HP” denoting “Haw Par”, were tailor-made for the Mansion, and should be preserved in-situ. ● Check condition, de-rust, repair, treat with rust preservative, and repaint to match with existing as necessary. ● Loosen decorative parts should be re-fixed by specialist as necessary.

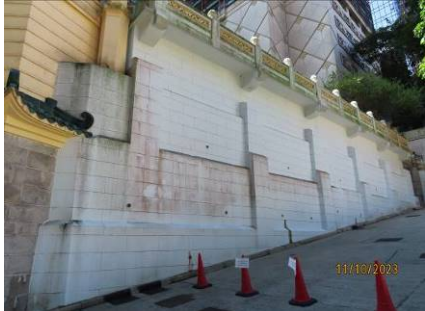
Item No.	Architectural Features to be Preserved and Conservation Guidelines	Photo
D.11	<p><u>External retaining walls</u> at the site boundary facing Tai Hang Road, the adjacent public footpath, and the Passage Area, including the buttresses, and groove on the walls, with pattern in plaster finishes including shanghai plaster</p> <p>Required Treatments:</p> <ul style="list-style-type: none"> ● The external retaining walls including the mentioned architectural features should be preserved in-situ. ● The wall surfaces should be repaired, cleaned and repainted with materials, design, pattern and colour to match with existing as necessary. ● All undesired vegetation on walls should be removed. ● Cracks found on the retaining wall should be repaired to prevent further deterioration, subject to the advice of geotechnical engineer. Any repair and strengthening work proposed as necessary should not alter the appearance of the retaining walls and should be submitted to AMO’s approval. <p>Recommended Treatments:</p> <ul style="list-style-type: none"> ● Mass concrete walls was constructed underground the Garden to reinforce the retaining walls during the last revitalisation works. The mass concrete walls which were embedded in the garden should be kept in place to minimize disturbance to the Garden. ● An opening was formed on the external retaining wall for passage of piping which had been concealed under the new connecting footbridge from services block. Reuse this opening for building services routing to minimize further disturbance to the retaining wall. 	<p>The wall facing Tai Hang Road</p>

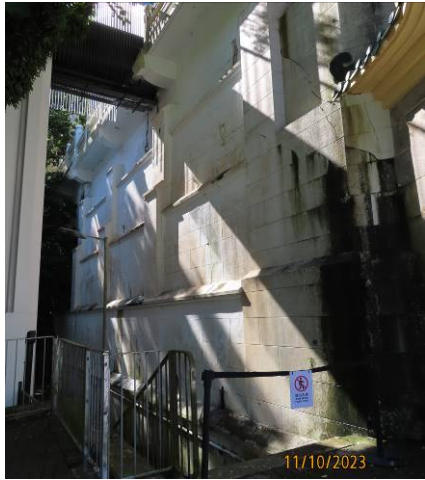
<p>The wall facing the adjacent public footpath</p>

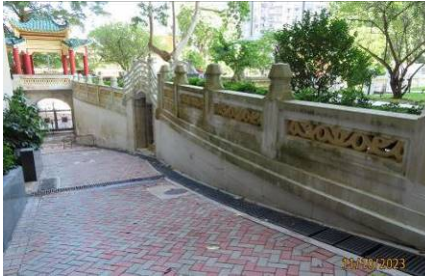
<p>The wall facing Passage Area</p>
